NUMBER: 12-249-18

SERVICE INFORMATION BULLETIN

APPLICABILITY: 2015-2017MY Legacy

SUBJECT: Rear Body Panel- Design Change

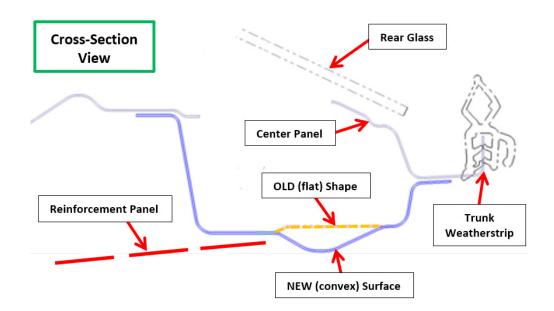
This Service Information bulletin advises of a design change made to the rear body panel. This panel is located between the trunk and the rear glass and incorporates the package shelf. It has been re-designed with 2 convex surfaces added to prevent items going into or out of the trunk from being scratched or caught by the rear edges of the reinforcement panels (shown in red) on the illustrations below.

View from inside trunk area looking upward toward underside of package shelf.

The new part numbers for the "PANEL COMPLETE R" are **53105AL02C9P** and **53105AL03C9P**. Always order the most up-to-date part as specified by the VIN.
