SERVICE BULLETIN

APPLICABILITY: All Models with Harman Audio / Infotainment **NUMBER:** 15-229-18
SUBJECT: Clock-Related Concerns and Troubleshooting **DATE:** 08/21/18

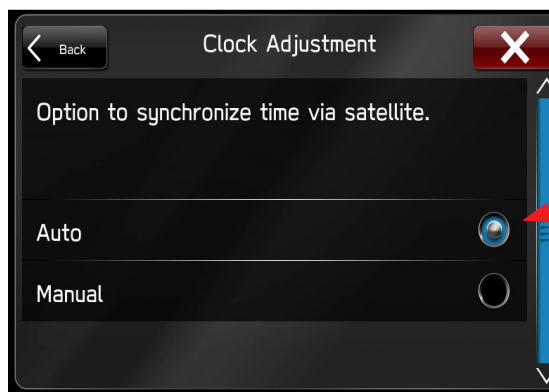
- a. What is the clock adjustment setting, Manual or Auto? (Clock setting information can be found under Settings > Vehicle > Clock Adjustment as shown below.)

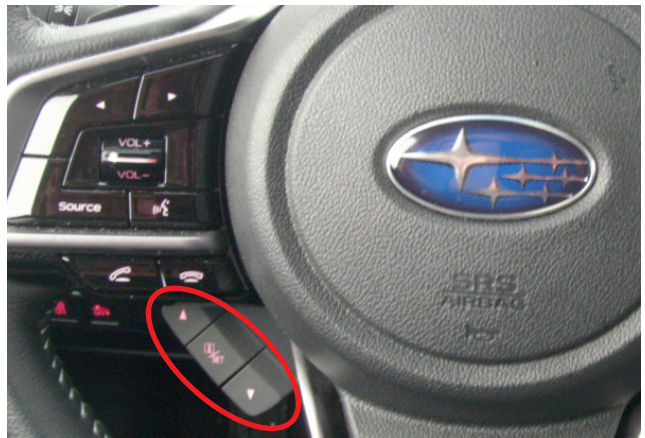
i. If vehicle is equipped with a color MFD, press the i/Set button until the MFD displays the “Hold SET button” screen. Hold the i/Set steering wheel button to enter the settings menu. The date and time settings are accessible from this menu.
