Date: 8/10/2018 Bulletin No: MTB-200917G Supersedes: MTB-200917F Section: Engine

Model Type:Quattroporte Automatic (M139) & GranTurismo (M145)Model Year:2007 to 2009Subject:Addendum - Noise from variator

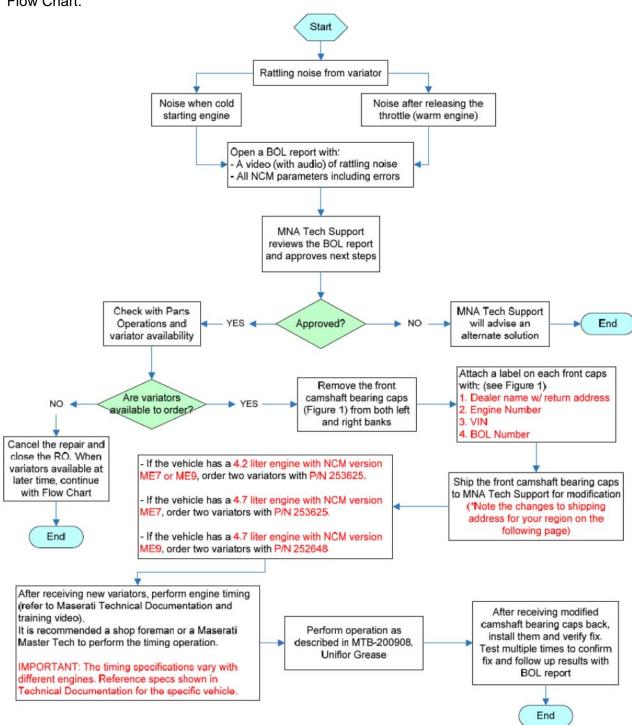
Maserati Quattroporte and GranTurismo vehicles with wet sump engine, with an engine number prior to 148697, may be affected by two different types of timing variator noise. In the event of a customer complaint of the noise from variator at cold start or when releasing the throttle in above mentioned vehicles, verify the engine number and follow the flow chart shown on following page.
