## Technical Information Bulletin

### E191

PACCAR MX-13 EPA2017 MY2017 Engine Brake Rocker Inspection

8/7/2018

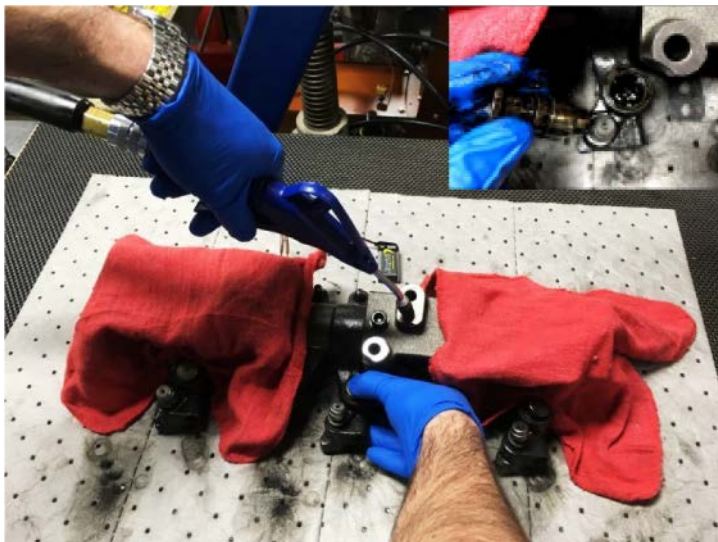
If the brake capsule is completely collapsed (i.e. no spring return) this is an indication of a broken spring and the entire exhaust rocker arm will need to be removed and replaced.

7. Using a rubber tipped blow gun, continuously apply light air pressure to the middle oil hole (2) while alternating between firmly pushing down and pulling out on the brake capsule foot to remove the brake capsule from the rocker arm bore.

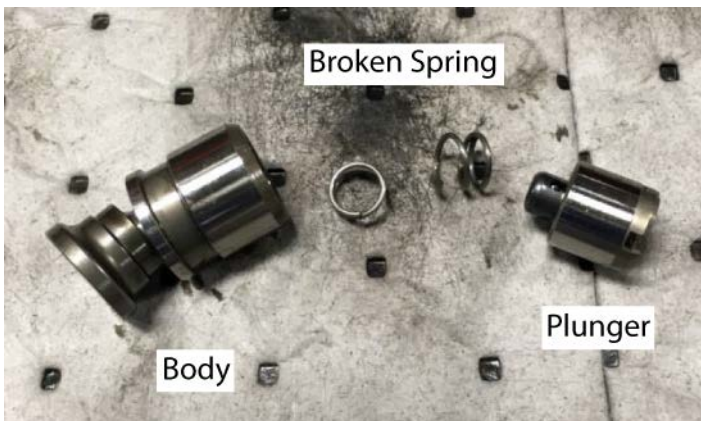
8. Separate the plunger from the brake capsule body to inspect the condition of internal return spring.
  - SPRING OK: Proceed to [STEP 9](#).
  - SPRING BROKEN: If the brake capsule return spring is broken then the affected rocker must be replaced. Proceed to [STEP 12](#) after all other capsules have been inspected.
