Technical Information Bulletin

E222

MY2017 and MY2018 Chassis with PACCAR MX-11/MX-13 engines with DTC P3912, P3857, and/or P3926

8/14/2018

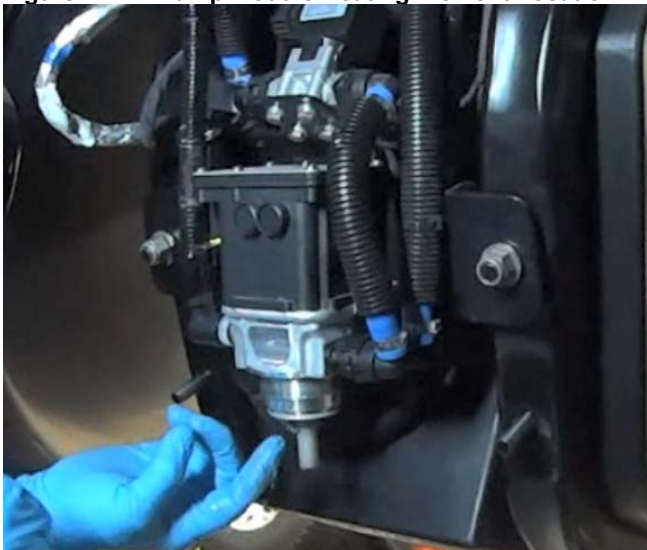
Figure 1 DEF Pump Module Heating Element Location

- DEF Pump Module and DEF dosing valve inlet screen must be replaced. DEF pressure line, between DEF dosing unit and DEF dosing valve must be flushed with distilled water to remove any residual debris.
- See Figure 1 for DEF Pump Module heating element location.
- See Figure 2 for an example of a plugged DEF dosing valve inlet screen.
- See Figure 3 for an example of a DEF dosing unit heating element with corrosion that is flaking off.

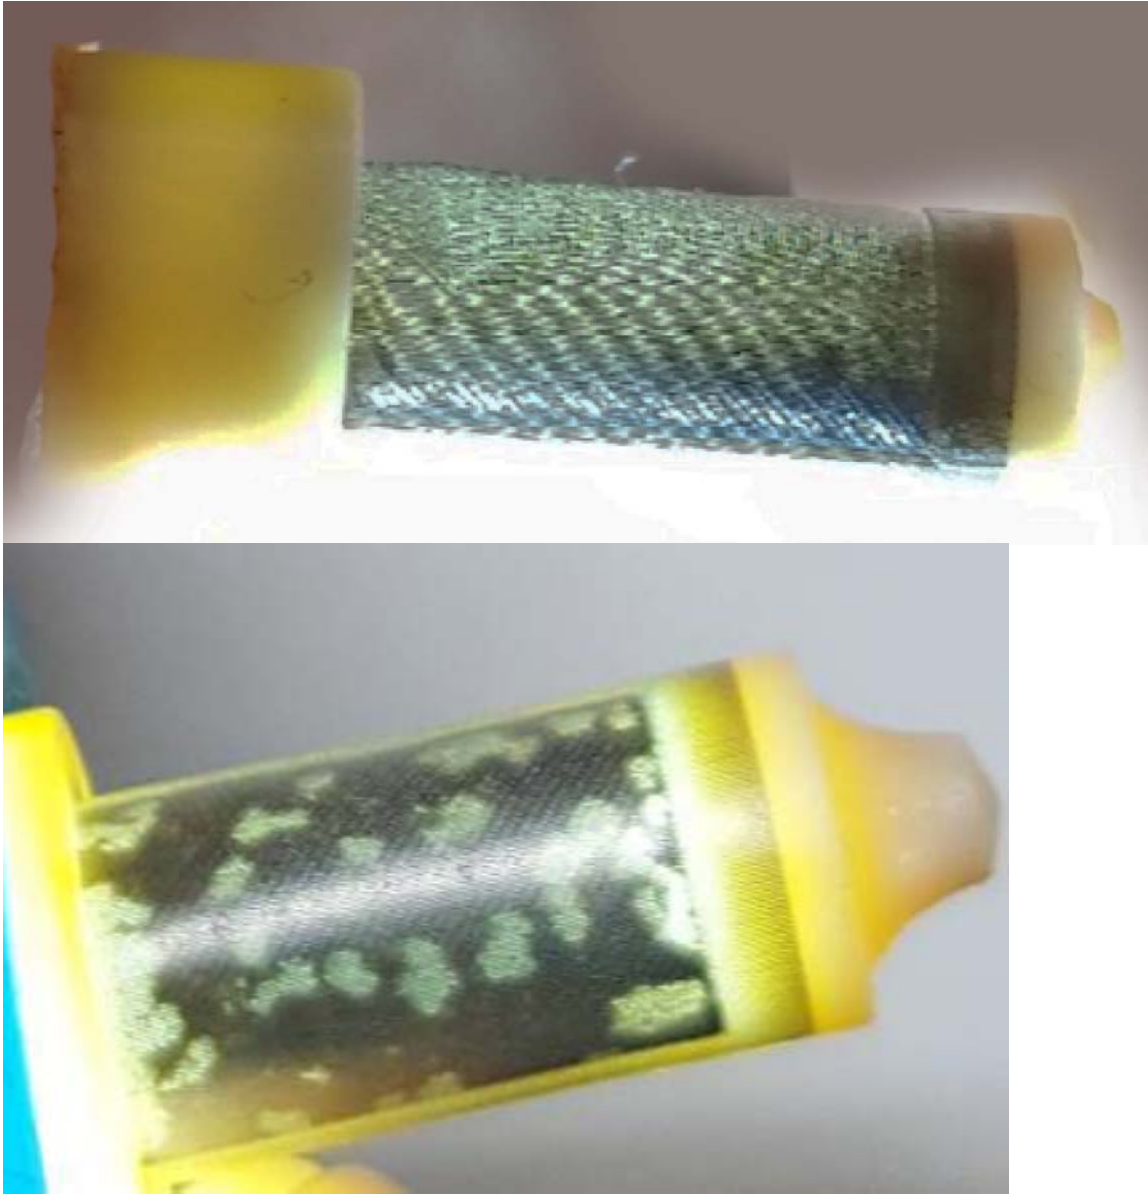
Figure 2 Plugged DEF Dosing Valve Inlet Screen Examples

DTC P3912, P3857, and/or P3926 may be caused by a plugged DEF dosing valve inlet screen. DEF dosing valve inlet screen may be plugged with debris when corrosion on the DEF dosing unit heating element flakes off.

If DEF dosing valve inlet screen is plugged with debris, and corrosion on DEF Pump Module heating element is flaking off.

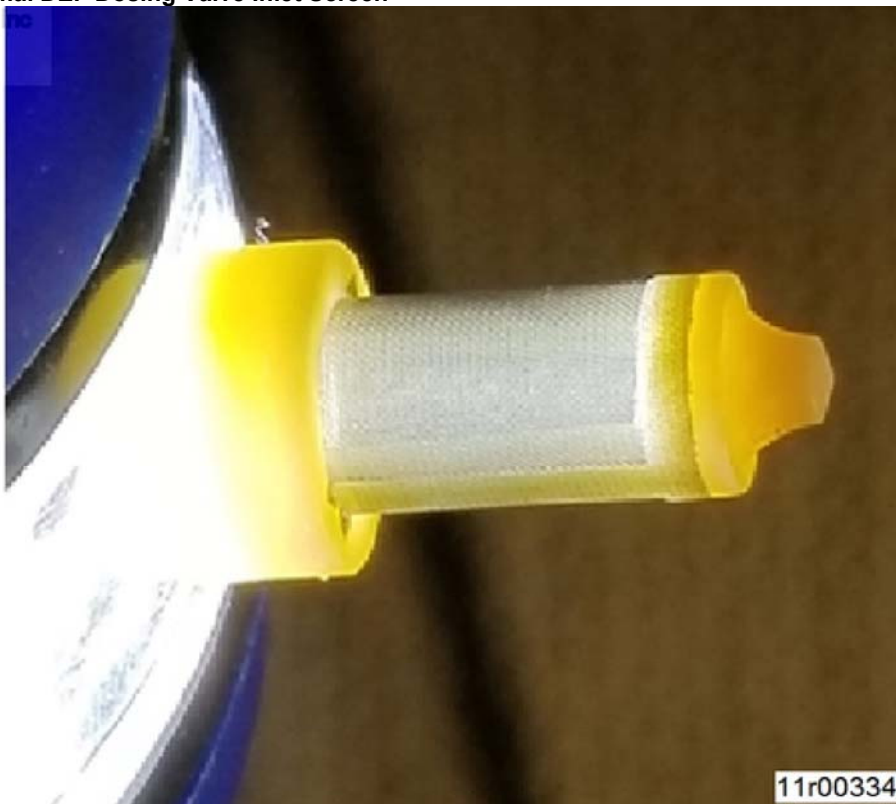
Figure 4 Normal DEF Dosing Valve Inlet Screen

If DEF dosing valve inlet screen is not plugged with debris, and corrosion on DEF Pump Module unit heating element is not flaking off.

- Do not replace DEF dosing unit for this condition. All DEF Pump Modules will have some level of discoloration/corrosion internally.
- See Figure 4 for an example of a clean DEF dosing valve inlet screen.
- See Figures 5, 6, and 7 for examples of DEF dosing units with acceptable levels of discoloration/corrosion.
- Continue with troubleshooting to find the root cause of the issue. File a long form claim.
