## FIELD INSPECTION INSTRUCTIONS

For Kenworth Outboard Sliding Fifth Wheels

## Technical Information Bulletin

JOST 5<sup>th</sup> Wheel Outboard Slider Clearance Inspection

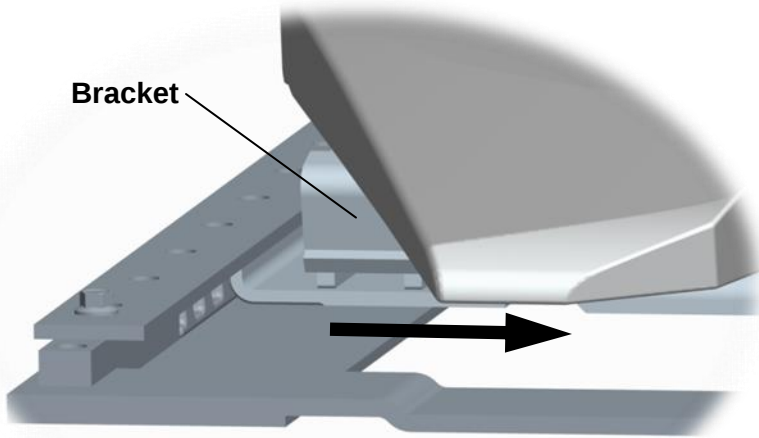
### Outboard Slider Side-to-Side Clearance Inspection

1. Using a pry-bar, force the topplate and bracket over to one side

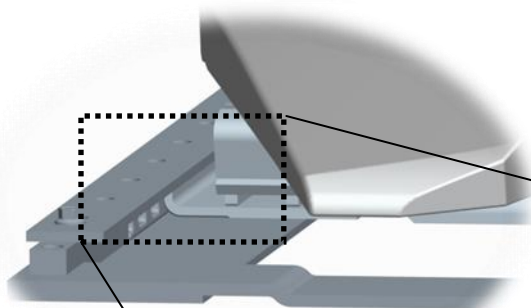
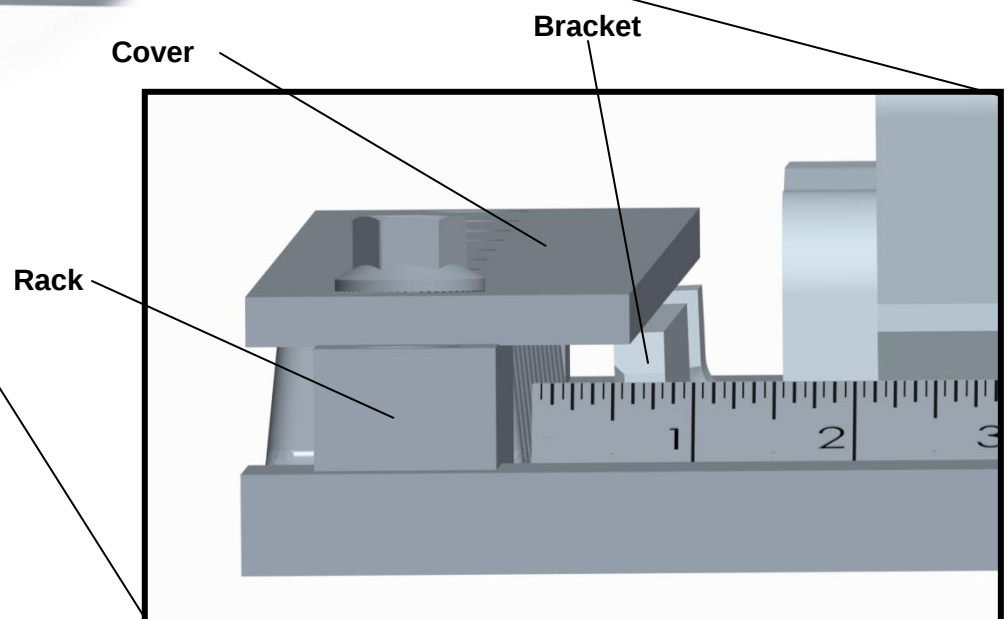
2. Place a ruler or tape measure under the cover to measure the gap between the rack and bracket. A gap of  $\frac{1}{2}$ " or more is the unit in question and is to be replaced.

If inspection does result in finding the (1) unit in question, DO NOT use the tractor. Please call 800-253-5105 to order a replacement bracket. Jost replacement procedure LT JSK37-13 will be provided.
