Technical Service Bulletin

90 Audi connect Key User entry cannot be selected in MMI menu, "Request user list manually"

90 18 92 2050584/3 May 2, 2018. Supersedes Technical Service Bulletin Group 90 number 18-91 dated March 22, 2018 for reasons listed below.

Model(s)	Year	VIN Range	Vehicle-Specific Equipment
A4, A5, Q5, and Q7	2018	All	With connected gateway

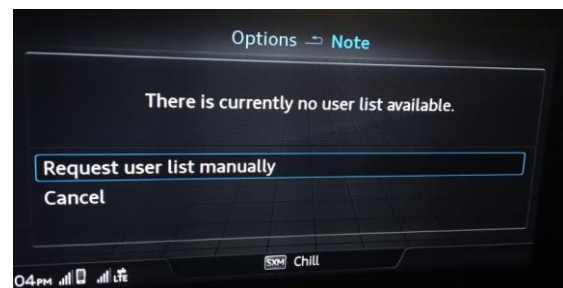
- The Key User login screen cannot be accessed in the MMI's Audi connect menu.
- When the customer attempts to access this screen, they see a persistent message of "Request user list manually" even after this option is selected multiple times (Figure 1).
- The customer's vehicle is a MY2018 built after CW 22/17.

Figure 1. Error message seen in the MMI.

The MMI is the user interface to the data bus on board diagnostic interface, J533 (address word 0019), also known as the connected gateway (cGW). When attempting the Key User pairing in the vehicle, the MMI communicates with the cGW and the cGW communicates with the Audi connect backend server (MBB). There is a known communication sync issue between the cGW and the MMI. A planned software update for the MMI is forthcoming, but in the meantime a short-term workaround solution is provided in the Service section.

1. Turn off the ignition.
2. Open the driver's door and leave it open (do not close the door). This will allow the vehicle bus to stay awake.
3. Wait 20 seconds and then turn the ignition on. Do not wait longer than 20 seconds. Letting the car sit longer will allow the vehicle bus to go to sleep. For this solution the vehicle bus must remain awake to allow the resync to occur.
4. Access the Audi connect user management screen and enter the key user information.
