## SERVICE BULLETIN

<b>Reference number:</b>	SB-01-1125	<b>Issued:</b> 20 August, 2018
<b>Subject:</b>	Touch pad cover	
<b>Model(s):</b>	Vantage 19MY	
<b>VIN Range:</b>	N00082 to N00289	
<b>Applicable to:</b>	All Dealers	
<b>Distribute to:</b>	<b>After Sales Manager</b> <b>Executive Manager</b> <b>Service Manager</b> <b>Sales Manager</b>	<b>Warranty Staff</b> <b>Technician(s)</b> <b>Parts Staff</b>

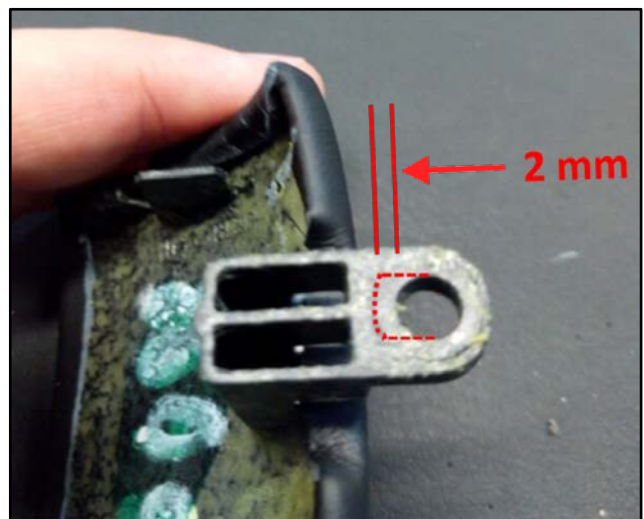
Figure 6

Aston Martin has found that the touch pad of some Vantage 19MY vehicles does not operate correctly. The buttons of the touch pad can catch on the touch pad cover.

6. Extend the screw hole in the touch pad cover by 2 mm to make a slot (refer to Figure 6).
