QUARANTINE NOTICE

Reference number:	QN-10-1127V2	Issued: 9 August, 2018
Subject:	Fuel filler latch	
Model(s):	Vantage 19MY	
VIN Range:	Refer to the separately published list of Vehicle Identification Numbers (VINs)	
Applicable to:	All Dealers	
Distribute to:	After Sales Manager Executive Manager Service Manager Sales Manager	Warranty Staff Technician(s) Parts Staff

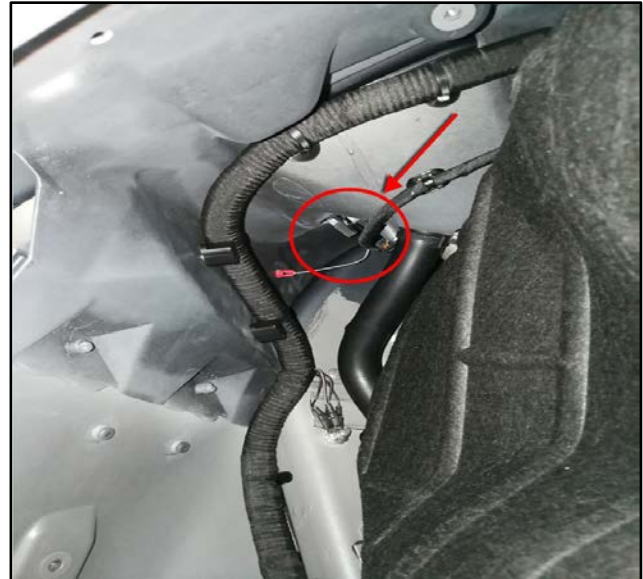
Figure 1

Aston Martin has found that the fuel filler latch mechanism can move out of position. If the fuel filler latch is not in the correct position the fuel filler door will not open or close correctly.

1. Remove the rear right-side wheel-arch liner (refer to Workshop Manual procedure 01.08.AK).
2. Remove the fuel filler latch from the clips that attach it to the vehicle body (refer to Figure 1).
