SERVICE BULLETIN

Reference number:	SB-18-1142	Issued: 24 August, 2018
Subject:	Parking sensor wires behind the radiator grill	
Model(s):	Vantage 19MY	
VIN Range:	All vehicles thru N00728	
Applicable to:	All Dealers	
Distribute to:	After Sales Manager Executive Manager Service Manager Sales Manager	Warranty Staff Technician(s) Parts Staff

Reason for this Service Bulletin

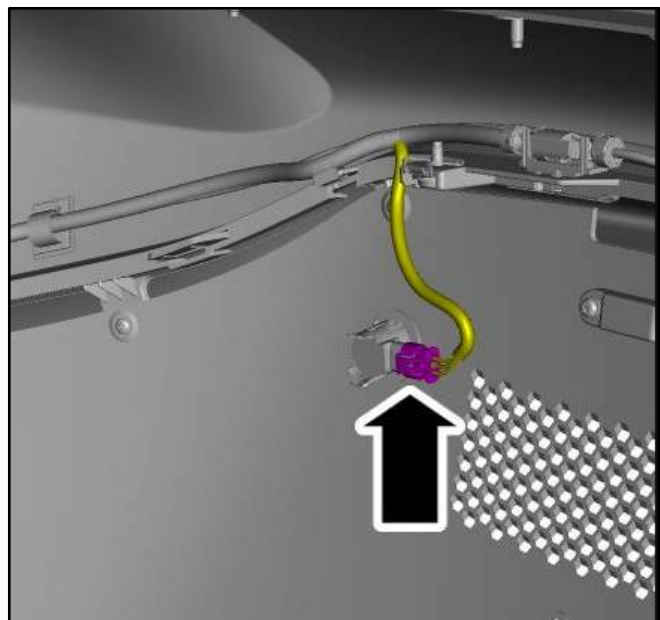
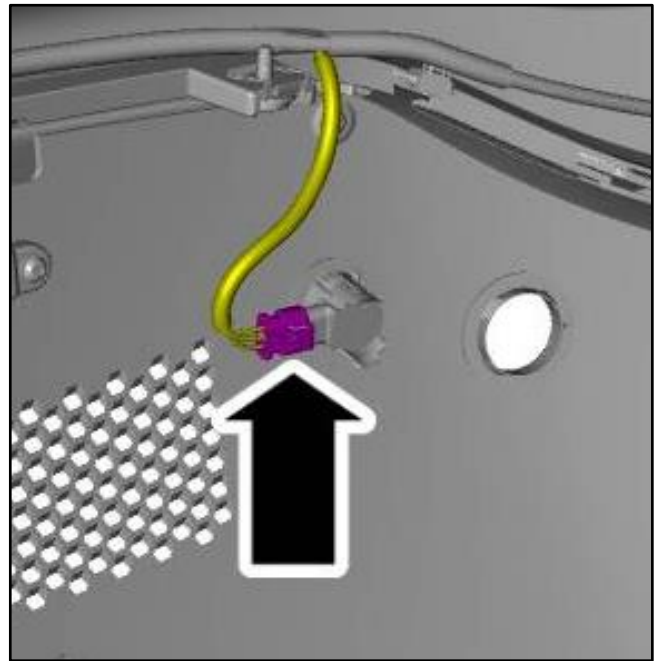
Some Vantage 19MY customers have complained that the wires of the front parking sensor connectors can be seen. This refers to the inboard parking sensor connectors behind the radiator grill of the vehicle.

1. Remove the front undertray. (Refer to Workshop manual procedure: 01.02.NB Front Undertray.)
2. Disconnect the electrical connectors from the two inboard parking sensors in the front of the vehicle. (Refer to Figure 1 and Figure 2.)
