SERVICE BULLETIN

AT18-007

SENTRA, VERSA SEDAN, AND VERSA NOTE; CVT FLUID LEAK SERVICE INFORMATION

APPLIED VEHICLES: 2013-2019 Sentra (B17)
2012-2019 Versa Sedan (N17)
2014-2018 Versa Note (E12)

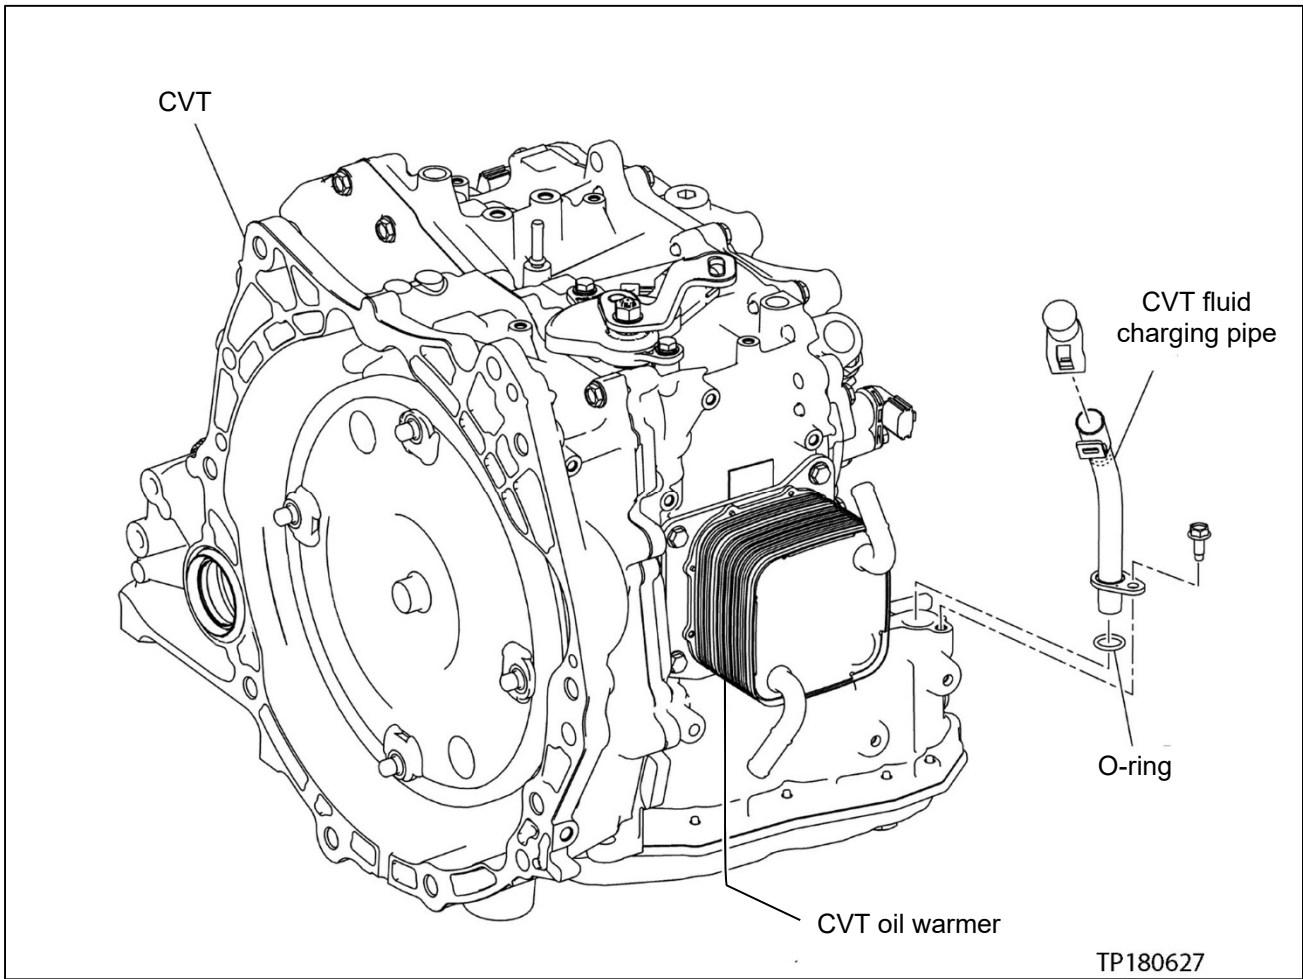
Figure 1

CVT related fluid leaks may be diagnosed incorrectly upon initial inspection causing incorrect parts replacement such as oil pan gaskets, axle seals, etc. To help reduce/eliminate the possible return of an applied vehicle, first check for leakage around the CVT fluid charging pipe.

When leakage is determined to be coming from the base of the CVT fluid charging pipe, remove it to inspect, and if necessary, replace the O-ring.
