## SERVICE BULLETIN

**APPLICABILITY:** 2014-2018MY Forester

**NUMBER:** 12-204-16R

**SUBJECT:** Pop, Click, Creak Sounds from the Rear Body Area

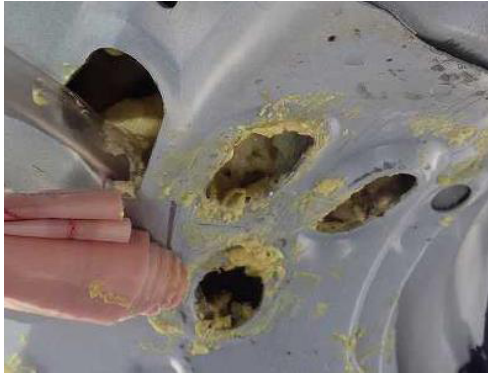
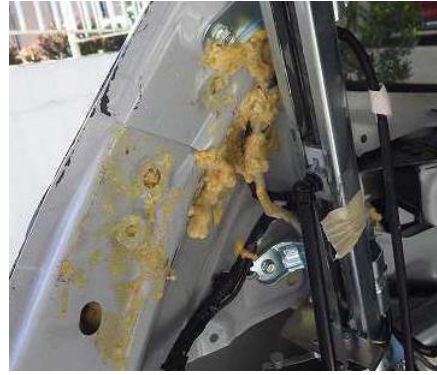
- **NOTE:** It is **NOT** recommended to use expandable foam as shown in the photos below. Once the foam has been applied, if the condition persists afterward, identifying the actual source of the sound, accessing and repairing it all become considerably more difficult along with increased chances of an ineffective repair.

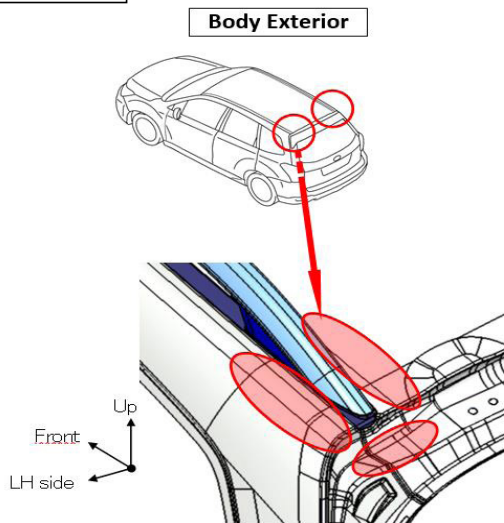
Using a set of chassis ears, check the areas circled in red in **Figure 1** above, the roof rail ends and stepped portions of the roof panel (the left side shown but always check both sides) for the sound. If the vehicle is not equipped with roof rails, check the areas at the ends of the roof moldings along with the stepped portion where the rear gate hinges are secured.

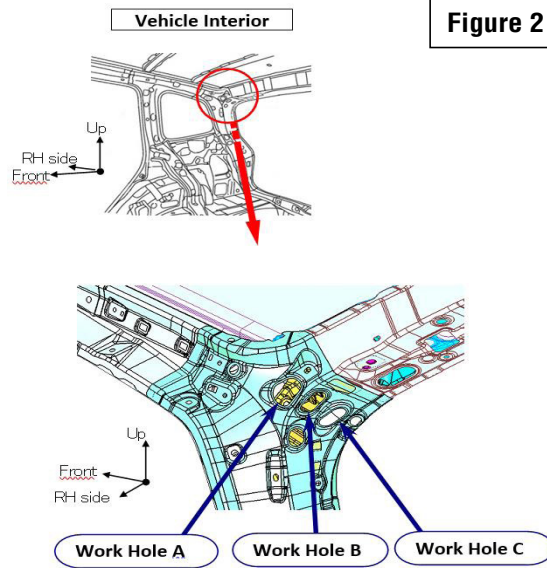
In **Figure 2** above, the term “Work Hole” is used for the access points where chassis ears can be inserted to help isolate the source(s) of the sound. Tools can be inserted into these holes where accessible to separate the layers of sheet metal and reduce or eliminate welding spatter by using a hammer and flat-nosed punch in other spot weld areas. Use the photo below to identify the work holes.

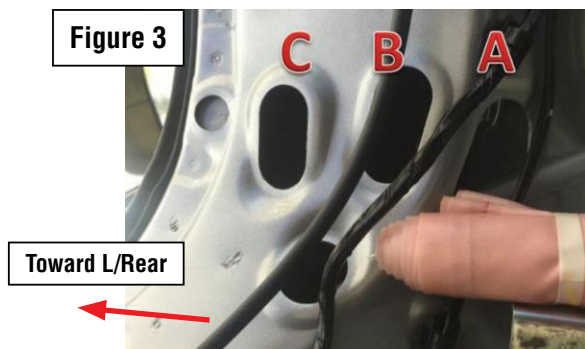
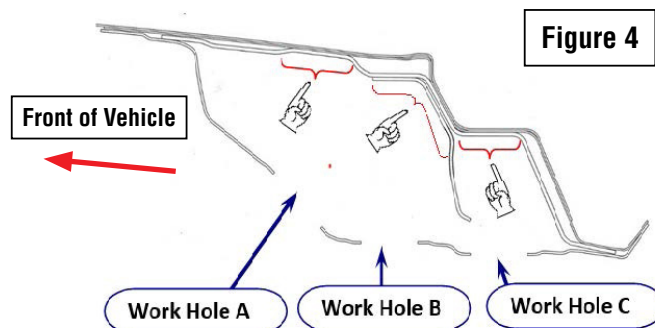
**Figure 3** below shows arrangement of the Work Holes and **Figure 4**, a cross-section view of how the sheet metal is layered in the suspect areas.

By working through the Work Holes, separate the layers (enlarging the gap) of sheet metal as shown in the procedure steps below. In areas where the edges of the metal layers are not accessible to separate, use a hammer and flat-nosed punch around the spot welds in the starred areas as shown in Steps 2 and 3 below to gain some separation. **SPARINGLY** apply a SMALL amount of the Endura penetrating grease into any new gaps created using the aerosol applicator tube. Always inspect for any weld spatter and crush or remove it as best as possible with either a flat blade screw driver or a “modified” tool as shown in the example photo below.

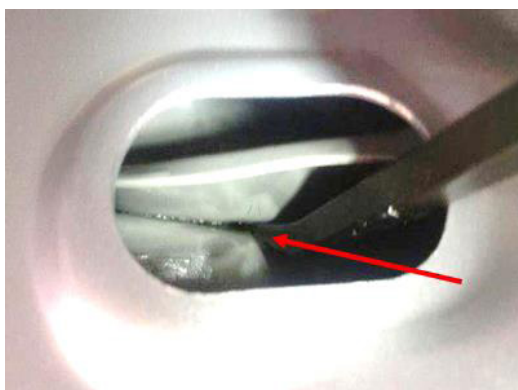
Photo shows weld spatter between layers of sheet metal.

After separating the layers of sheet metal, **SPARINGLY** apply a **SMALL** amount of the Endura penetrating grease into any newly-created gap using an aerosol applicator tube to be more precise and eliminate any overspray.
