Technical product information

Topic	Bentayga W12 - Bentley dynamic ride system fault displayed in Driver Instrument Panel
Market area	Bentley: worldwide (2WBE),Hongkong-Macau (5HK)
Brand	Bentley
Transaction No.	2051553/1
Level	EH
Status	Approval
Release date

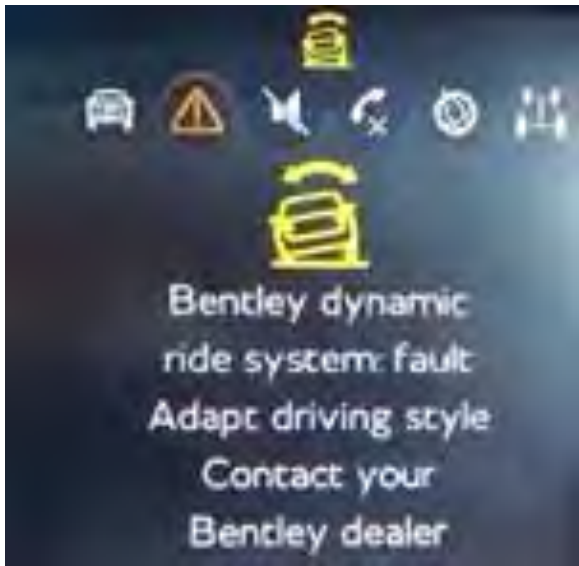
Bentley dynamic ride system fault displayed in the Driver Instrument Panel.
