# Technical product information

| Topic | Flying Spur - Rearview camera coding message |
| Transaction No. | 2052111/1 |

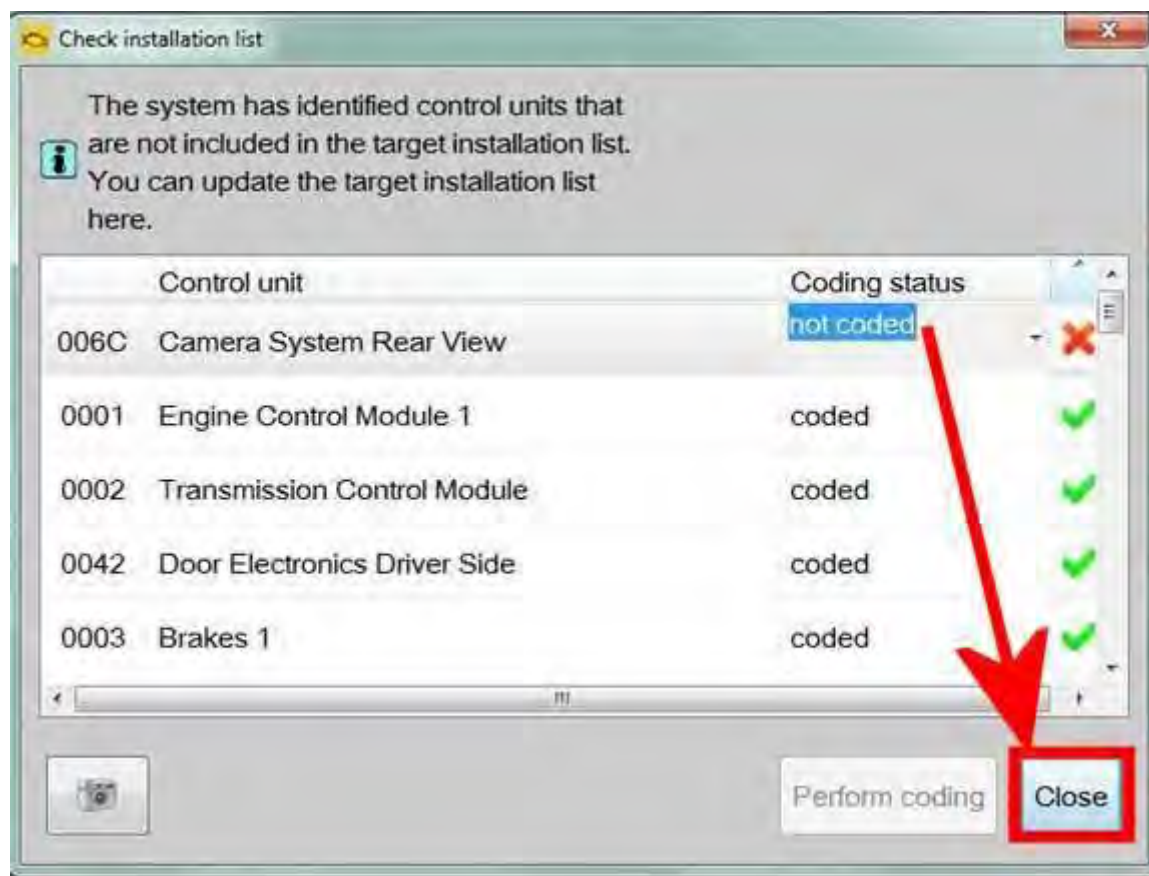
Figure 1

When using Offboard Diagnostic Information System (ODIS) a message relating to 006C – Camera System Rear View not coded is shown on the diagnostic tester screen

- Although the rear view camera is shown as not coded, this should be ignored as the camera is coded correctly, the prompt has no negative effect on the performance of the rear view camera system

Referring to Figure 1, When the screen is shown **ALWAYS** select **CLOSE**

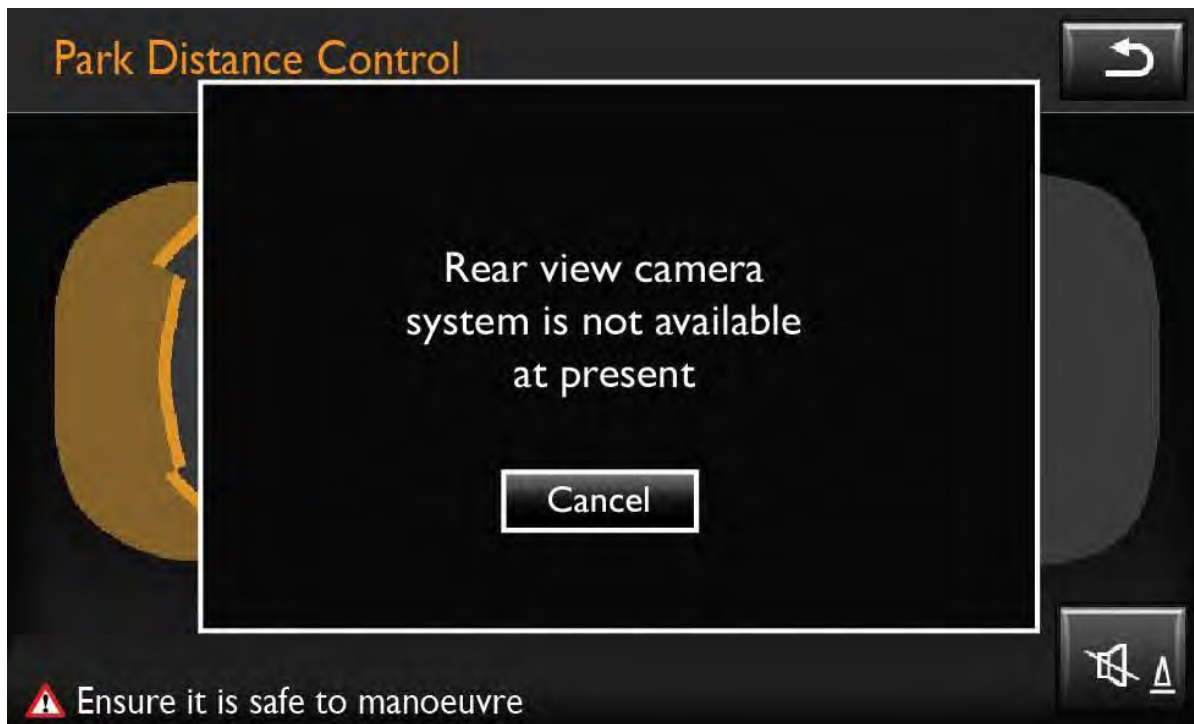
Do not under any circumstances select Perform coding as the warning message as shown in Figure 2 will remain present, DTC's will also be evident which cannot be easily rectified
