GROUP  
**Body**

MODEL  
**Multiple Models**

NUMBER  
**PS299 (Rev 3, 09/19/2018)**

**SUBJECT:** CORRECT PROCEDURE FOR RAISING  
WINDSHIELD WIPERS

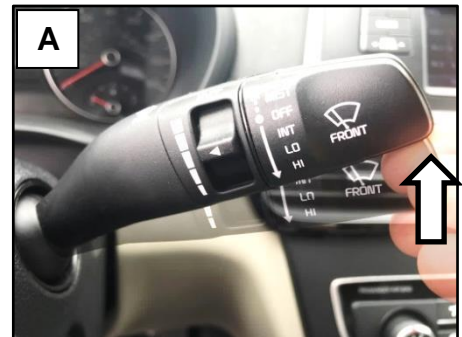
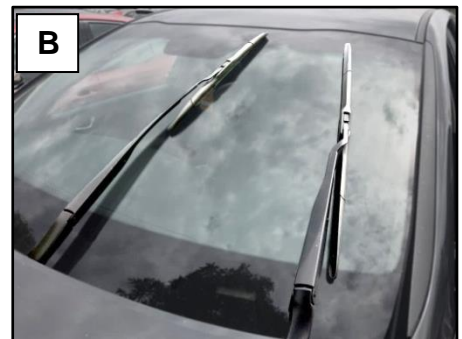
When servicing the windshield wipers on the listed vehicles below during PDI, make sure to use the procedure outlined below to raise the wiper arms to the fully vertical position in order to **avoid damaging the paint on the rear edge of the hood**. It is important to note that the wipers on these vehicles are recessed under the hood to provide better appearance and reduced wind noise characteristics. This procedure applies to both key start and SMK type ignition systems.

1. Turn the vehicle ignition ON with the engine OFF and then turn the ignition OFF.
2. Within three (3) seconds after turning the vehicle ignition OFF, raise the wiper blade control stalk and hold it for more than two (2) seconds (A).
3. The wiper arms will move upward and stop in the fully vertical position (B). The wiper arms may now be moved away from the windshield for any needed PDI process or service procedure.
4. Once finished servicing the wipers, turn the vehicle ignition ON with the engine OFF. Then, move the wiper blade control stalk up to return the wipers to the “parked” position.
5. Finally, turn the vehicle ignition to the OFF position.
