**\*\* TECHNICAL INFORMATION NOTICE \*\***

DATE: August 8, 2018  
TO: Mitsubishi Motors US & Puerto Rico Dealer Service and Parts Managers  
RE: Brake Fluid Leak at Brake Master Cylinder  
TIN NO. TIN-18-35-001

**AFFECTED VEHICLES:** 2014 – 2017 Outlander produced **before** June 5, 2017

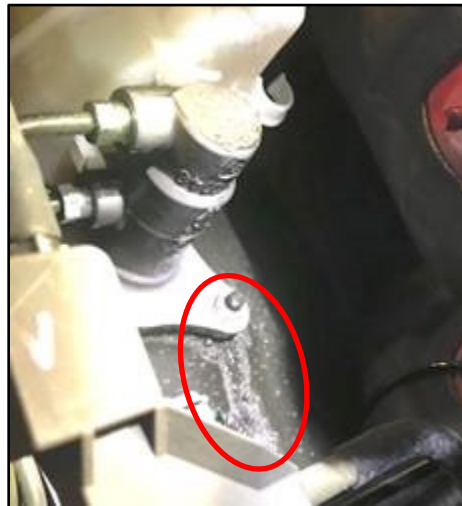
For concerns of the brake warning light coming on due to low brake fluid in the brake fluid reservoir and brake fluid is found on the front of the brake booster, **DO NOT** replace the brake master cylinder.

1. Loosen both brake line nuts completely at the brake master cylinder.
2. Loosen (**do not completely remove**) the two mounting nuts of the brake master cylinder to the brake booster.
3. Reinstall the brake line nuts to the brake master cylinder, confirming the flare tube is installed straight into the brake master cylinder, hand tighten the brake line nuts while confirming the brake line remains straight into the brake master cylinder body, and torque the brake line nuts to 16 ft-lbs (21 N-m).
4. Retighten the mounting nuts of the brake master cylinder to the brake booster to 18 ft-lbs (25 N-m).
5. Refill the brake fluid reservoir and perform brake bleeding.
6. Clean the brake fluid leak from the brake booster and surrounding areas.
7. Check for any other sources of leaks and repair as needed.
8. Test drive the vehicle and confirm proper brake operation.
