Technical Service Bulletin

SUBJECT:		No: TSB-18-54-009	
DISPLAY AUDIO FAILURE IN COLD TEMPERATURES		DATE: August 2018	
		MODEL: See below	
CIRCULATE TO:	<input type="checkbox"/> GENERAL MANAGER	<input checked="" type="checkbox"/> PARTS MANAGER	<input checked="" type="checkbox"/> TECHNICIAN
<input checked="" type="checkbox"/> SERVICE ADVISOR	<input checked="" type="checkbox"/> SERVICE MANAGER	<input checked="" type="checkbox"/> WARRANTY PROCESSOR	<input type="checkbox"/> SALES MANAGER

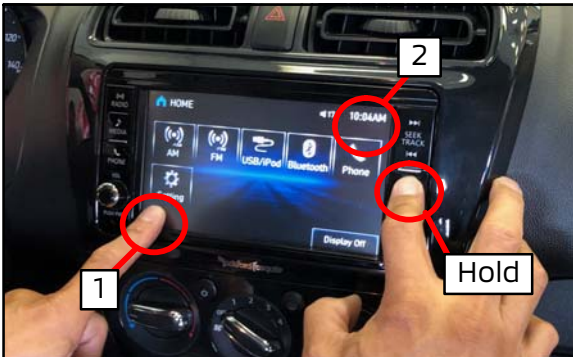
1. While pressing the "Home" button, touch the bottom left corner of the Audio Display briefly. Then touch the top right corner of the Audio Display for at least 2 seconds.

The service mode will be initiated. Then the "Service" screen will be displayed.

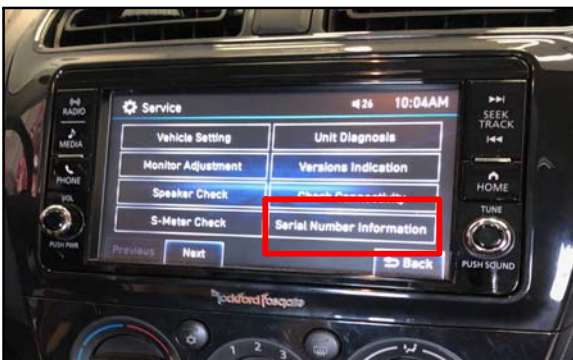
2. Select "Serial Number Information" on the "Service" screen.

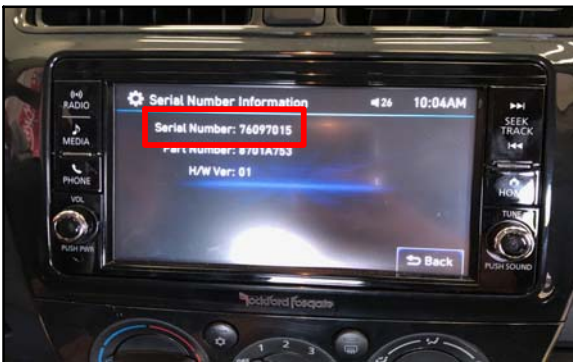
3. A serial identification number will be displayed.

- If the serial number is **before 7Y107002**, then continue on to step 4.
- If the number is **7Y107002 or after** do **NOT** continue using this TSB. Please contact Techline to open a Techline Case.
