GST-TSB-18-002 Bulletin **Technical Service**

Running Board Sagging

Service Category:	Accessory		
Section:	Body	Market:	USA

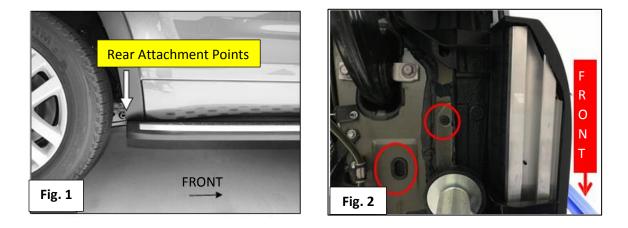
- 2. Once FTS has provided next steps, proceed to step 3.
- 3. Does the vehicle exhibit condition?
 - a. YES Proceed to Step 4
 - b. **NO** This TSB does not apply
- 4. Raise the vehicle on lift and locate the rear attachment points of the running board (Fig.1)
- 5. Proceed to install the Supplemental Brackets. Steps 6-17 show how to install the supplemental bracket on RH of vehicle.
- 6. Remove and discard the rubber plugs indicated on **Fig. 2** which are located on the underside of vehicle.
