INSTRUCTION TO SERVICE

ITS: 58416	
SECTION:	219 Engine and Transmission
WRITTEN BY:	Mike Pearson
SUBJECT:	Inspect all buses for correct O2 sensor seals and insulation installation

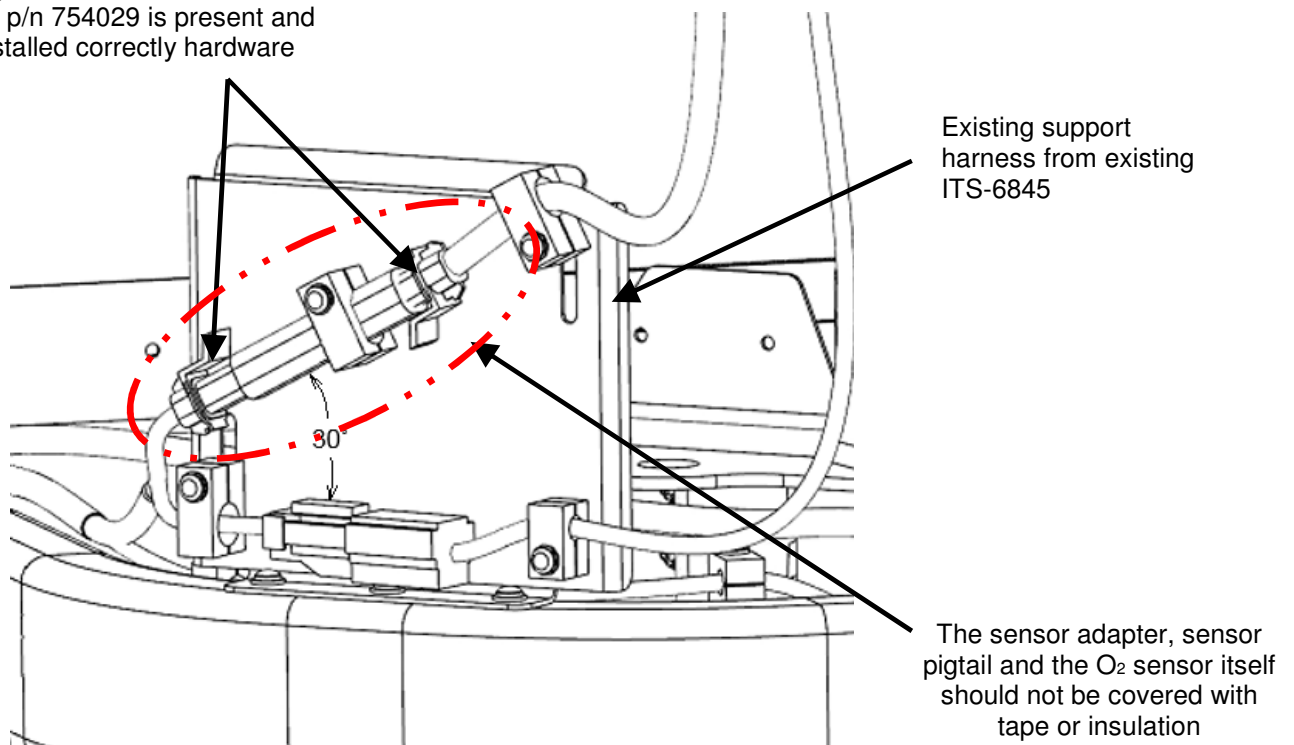
Figure 1: O₂ Sensor Blue Seal Locations

3. Examine the existing O₂ sensor for correct insulation installation, any existing high temperature tape or loom installed should not cover the sensor adapter, sensor pigtail or the O₂ sensor itself. If insulation or tape is present in these areas it must be removed.
4. Verify the correct blue connector seal p/n 754029 is present and installed correctly on the adapter that comes with the aftertreatment harness from Cummins, see figure 1.
5. Verify the correct blue connector seal p/n 754029 is present and installed correctly on the New Flyer side male type connector that connects to the Cummins O₂ sensor adapter, see figure 1.

Verify the correct blue connector seal p/n 754029 is present and installed correctly hardware
