### **✓ DTCs P0420 & P0421: PROPER CATALYST DIAGNOSIS AND PART IDENTIFICATION** – 2013-15 Outlander Sport/RVR.

### **TIN-18-13-002: ENGINE ECU SOFTWARE UPDATE IN TSB-18-13-001 & TSB-18-13-002 ADDRESSES BOTH DTC P0068 & P061A** – 2018 Eclipse Cross.

### **TIN-18-23-003: COOLANT LEAKING FROM CVT HOSES – COLLECTION OF PARTS COMPLETE**

### **TIN-18-35-001: BRAKE FLUID LEAK AT BRAKE MASTER CYLINDER**

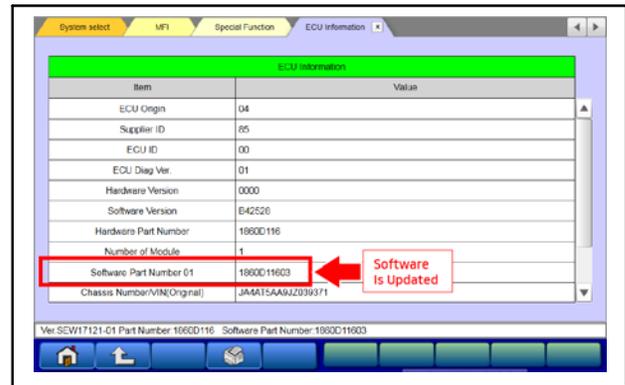
"An Engine ECU software update will be available soon to address MFI DTCs P0068 and P061A that have been improperly set. When reprogramming the Engine ECU software to resolve DTC P0068 or P061A, be sure to first check the software part number as described in TSB-18-13-001 and TSB-18-13-002.

**If the Software Part Number listed is 1860D11603 or higher, then the software update for P0068 and P061A has been completed. There is no need to complete the procedure in both TSBs, as software level 1860D11603 addresses both issues."**

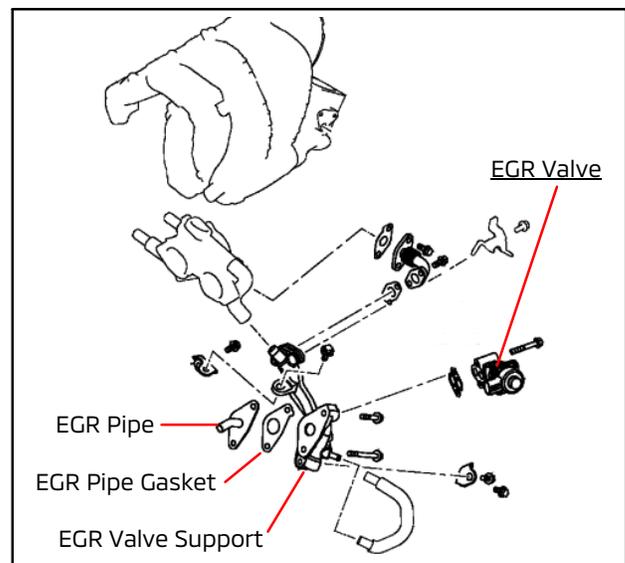
### **DTC P0171: FUEL SYSTEM LEAN** – 2011 & newer Outlander Sport/RVR.

When diagnosing a fuel system lean code, ensure the quality of fuel and that excessive levels of Ethanol are not present.

Also check for intake vacuum leaks at the gaskets and connection points of the EGR Pipe, EGR Pipe Gasket, and EGR Valve Support (see illustration). Clean and repair parts as appropriate to correct the source of the vacuum leak.

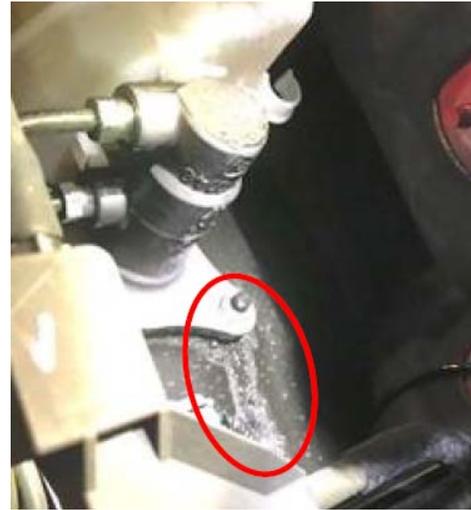
"For concerns of the brake warning light coming on due to low brake fluid in the brake fluid reservoir and brake fluid is found on the front of the brake booster, **DO NOT** replace the brake master cylinder.

Perform the following:

1. Loosen both brake line nuts completely at the brake master cylinder.
2. Loosen (**do not completely remove**) the two mounting nuts of the brake master cylinder to the brake booster.
3. Reinstall the brake line nuts to the brake master cylinder, confirming the flare tube is installed straight into the brake master cylinder, hand tighten the brake line nuts while confirming the brake line remains straight into the brake master cylinder body, and torque the brake line nuts to 16 ft-lbs (21 N-m).
4. Retighten the mounting nuts of the brake master cylinder to the brake booster to 18 ft-lbs (25 N-m).
5. Refill the brake fluid reservoir and perform brake bleeding.
6. Clean the brake fluid leak from the brake booster and surrounding areas.
7. Check for any other sources of leaks and repair as needed.
8. Test drive the vehicle and confirm proper brake operation."

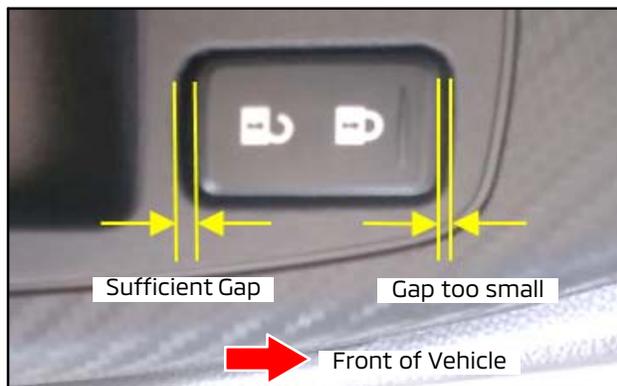
### DRIVER'S DOOR LOCK BUTTON STICKS IN "UNLOCK" POSITION – 2018-19 Eclipse Cross.

Should you encounter the subject condition, check for proper clearance between the door lock button and trim cover at the front edge of the button.

Too small of a gap at the front may cause the unlock button to stick at times. You can use a business card or 0.3 mm feeler gauge to compare the gap at the front and rear of the door lock button.

To correct the condition, remove the door panel by following the procedure in the Service Manual, then loosen the three mounting screws that secure the master

switch to the trim cover. While pressing rearward on the switch, tighten the screws.
