Mack Models

Volvo Models

Title Grounding Bus Bar On Frame Rail Stud; Inspection To Be Performed For Power And Ground, Data Link DTCs - **US13 And Newer Emissions, Common Model Year 2018 And Newer**

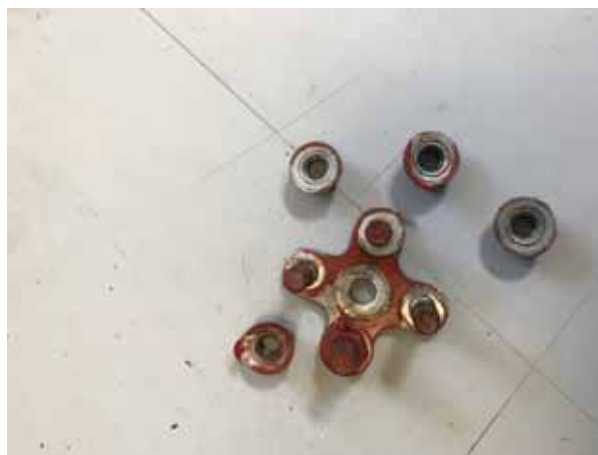
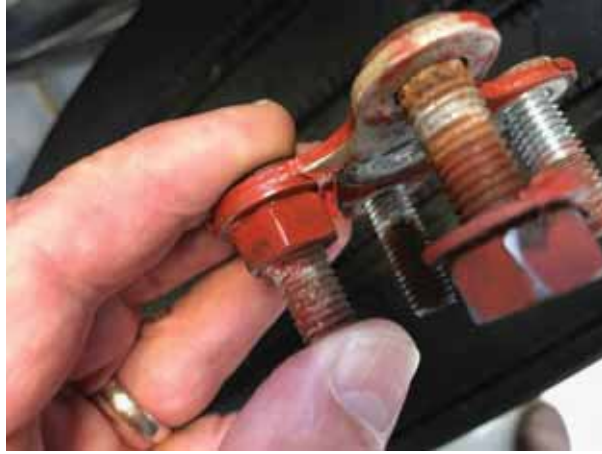
Cause The **ground star** is painted before the cables are installed causing insufficient grounding.

Solution The ground star is located on the driver's side frame rail near the battery box and fuel tank. Multiple grounds have been moved to this location. If the ground becomes loose or if it gets the protective coating in between the terminals the ground star needs to be removed, cleaned, and the protective coating needs to be reapplied.
