Subject: ELECTRICAL CONCERN AND/OR MULTIPLE DTC'S DUE TO AFTERMARKET DEVICE	M-Tips No.: MT-004/18
	Last Issued: 09/14/2018

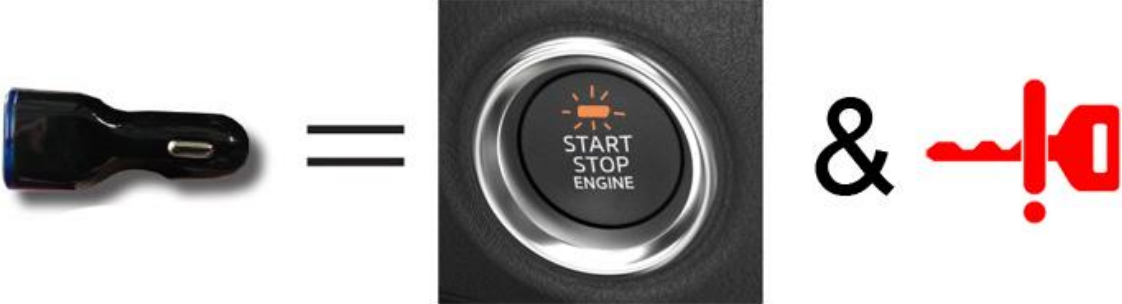
Aftermarket Cell Phone Charger connected to 12V outlet	Engine Start/Stop Button Amber Indicator Light Flashing	Key Warning Light (red)

If you determine that no aftermarket devices have been installed, continue with normal Workshop Manual diagnosis.

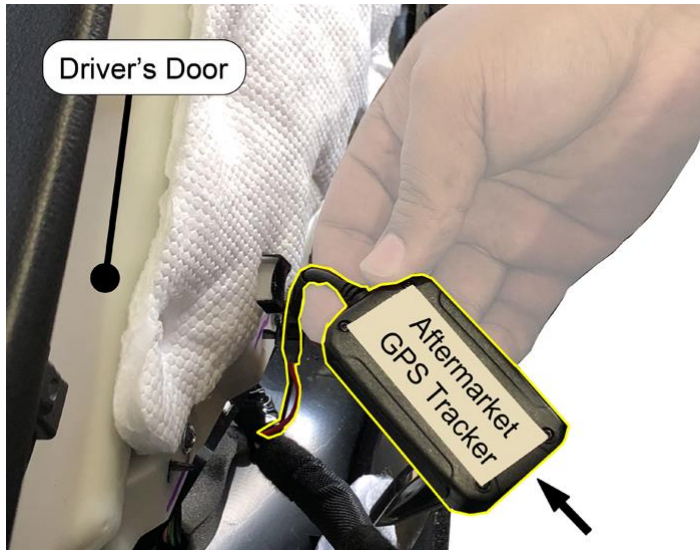
Below are examples of concerns due to an aftermarket GPS tracking device wired to the power window main switch:

- Engine no start
- Battery discharge
- Main relay buzzing

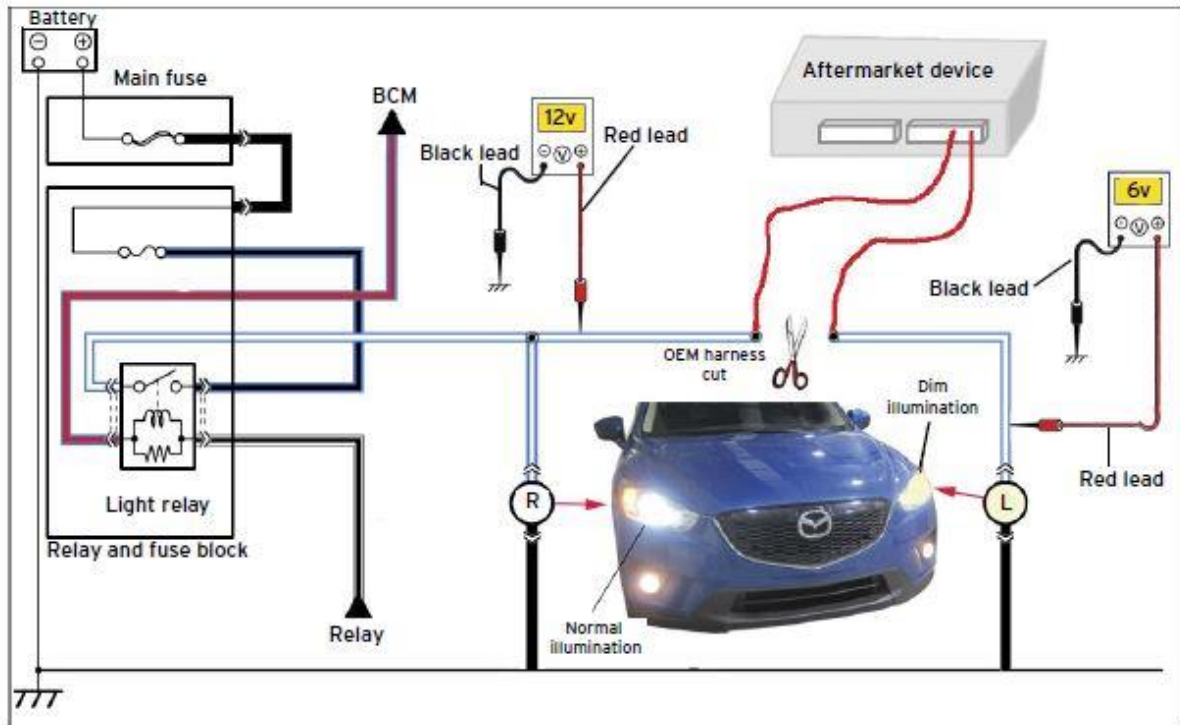
Below is an example of a dim headlight. The aftermarket device changed the headlight circuit resistance, causing a dim headlight.
