Subject: ENGINE NO START AND / OR REAR VIEW MONITOR DISPLAY IS BLURRY DUE TO AFTERMARKET ELECTRICAL DEVICE	M-Tips No.: MT-007/18
	Last Issued: 09/14/2018

APPLICABLE MODEL(S)/VINS

2014-2018 Mazda3
 2014-2018 Mazda6
 2016-2019 CX-3
 2013-2018 CX-5
 2016-2019 CX-9
 2016-2019 MX-5

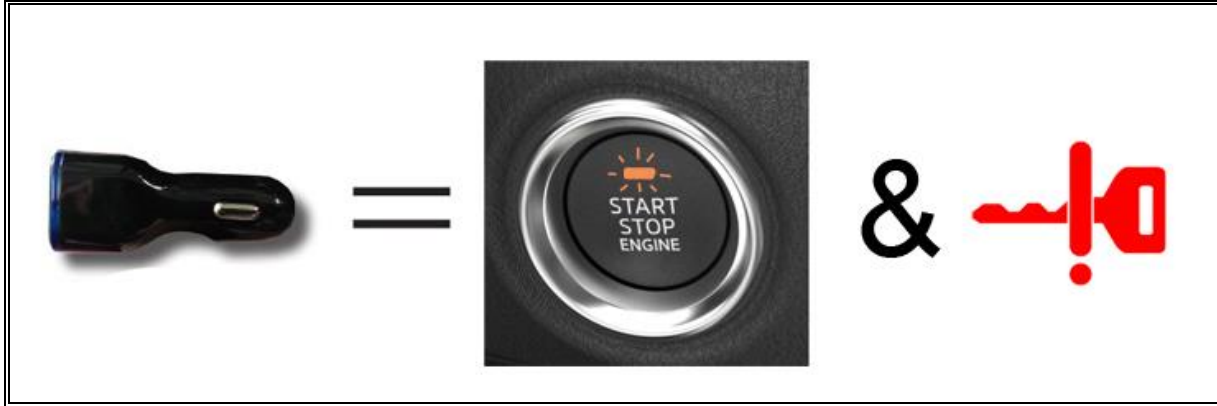
Engine No Start:

Aftermarket Cell Phone Charger connected to 12V outlet	Engine Start/Stop Button Amber Indicator Light Flashing	Key Warning Light (red)
--	--	----------------------------

Warranty Compliance Note: Repairs for this concern are not covered under Mazda’s warranty policy. Advise the customer not to use the aftermarket device that is causing the concern.

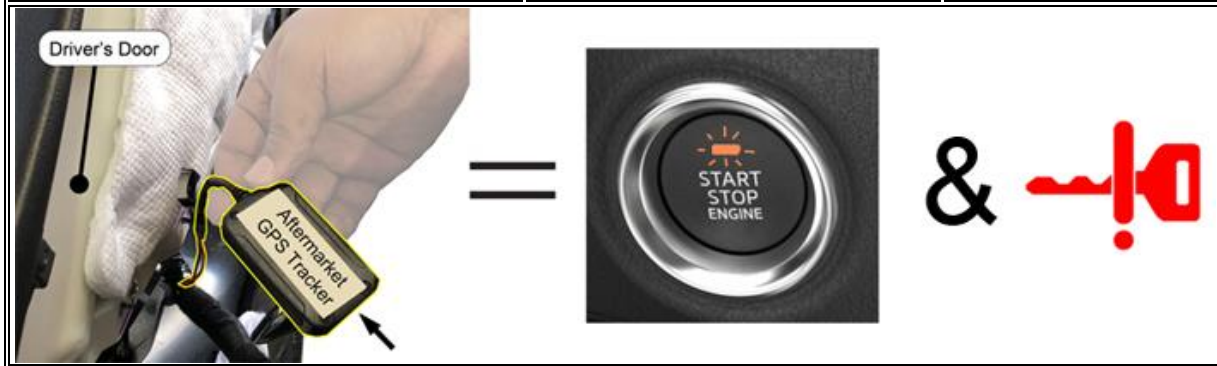
Aftermarket GPS tracking device wired to the power window main switch	Engine Start/Stop Button Amber Indicator Light Flashing	Key Warning Light (red)
---	--	----------------------------

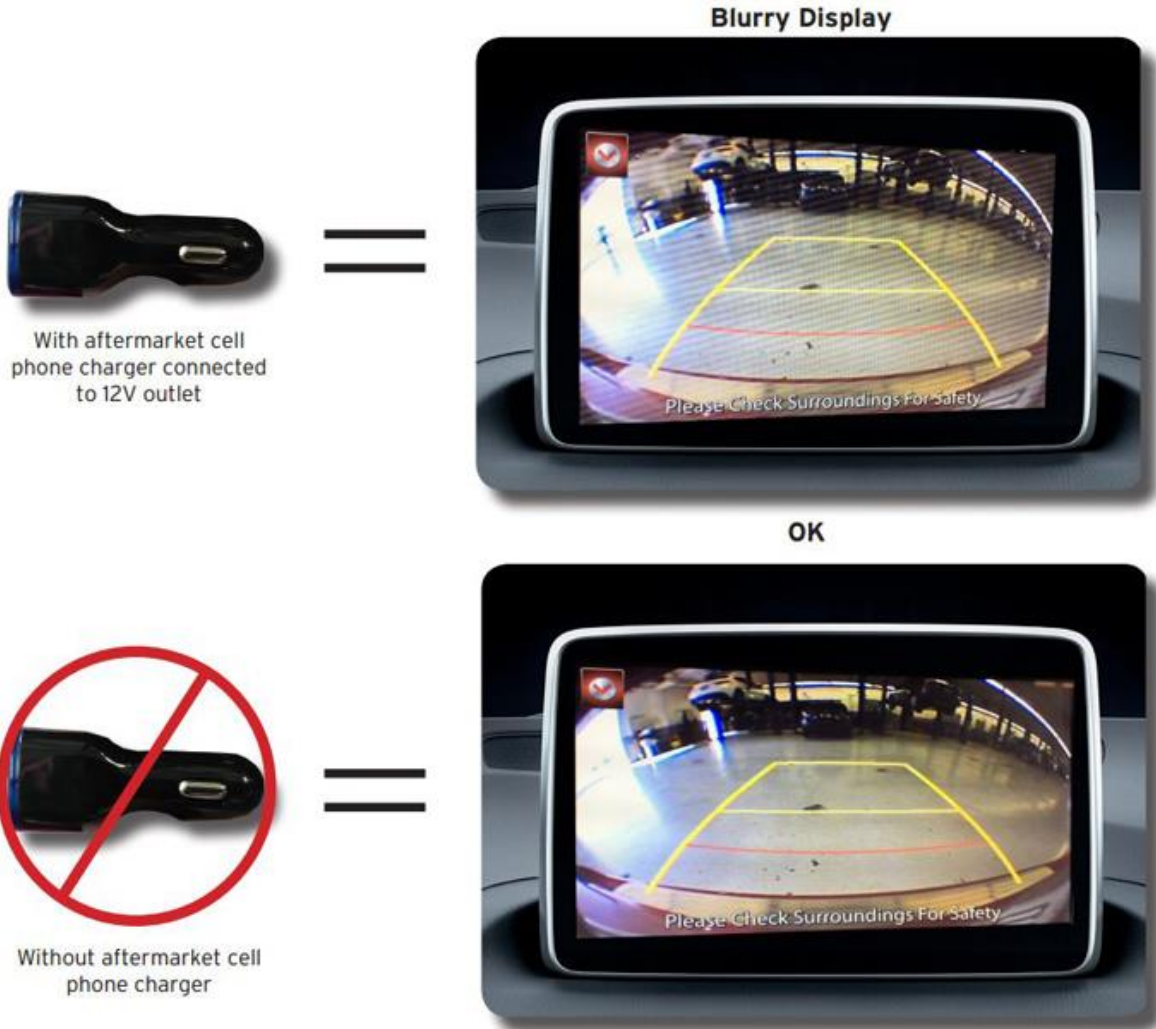
Example 2

Rear View Monitor Display is Blurry:
