Technical Service Bulletin

Mazda North American Operations
Irvine, CA 92618-2922

Subject: OIL SEEPAGE AT ENGINE FRONT COVER	Bulletin No.: 01-018/18
	Last Issued: 09/21/2018

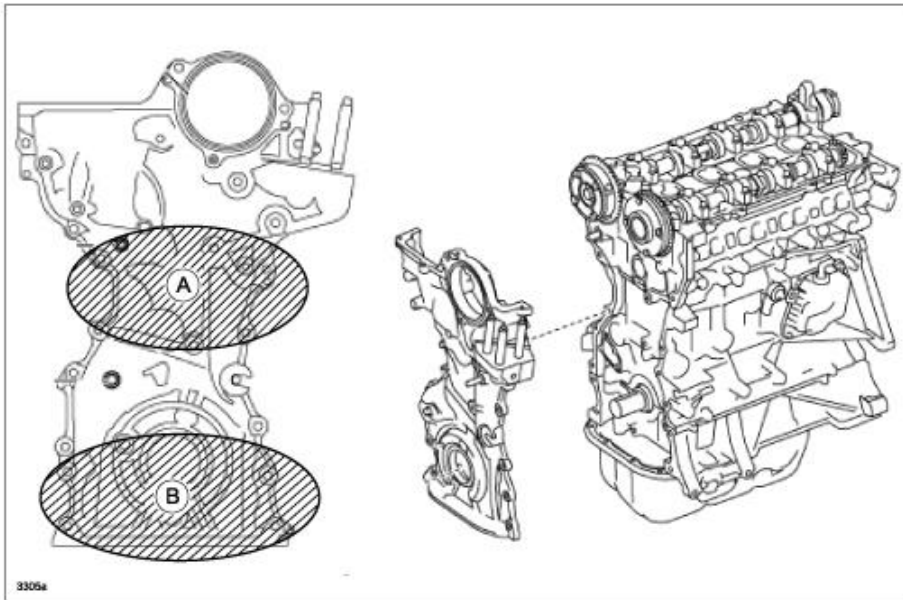
Some vehicles may exhibit oil residue on the engine front cover from seepage around the joint portion (A) between the cylinder block and head. It becomes very noticeable with dust adhesion. In some cases, the area of oil residue extends down to around the joint portion (B) between the engine front cover and the oil pan.

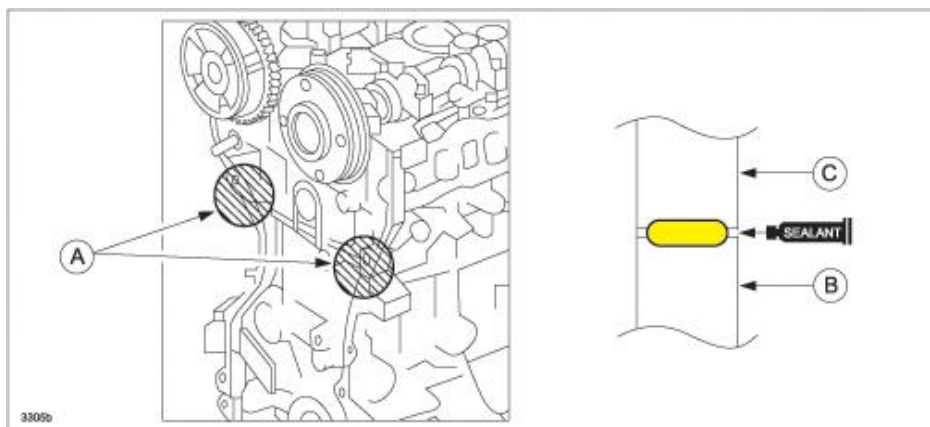
This may be caused by oil escaping from a fine clearance created at the sealant applied to joint (A) between the cylinder block (B) and head (C) when the engine was pressurized during leak testing on the engine assembly line.
