Subject: UNUSUAL NOISE FROM REAR OF VEHICLE	Bulletin No.: 02-015/18
	Last Issued: 09/27/2018

- 2014-2016 Mazda3 (Japan built)
- 2017-2018 Mazda3 (Japan built) vehicles with VINs lower than JM1BN*****179073 (produced before Dec 1,2017)
- 2013-2016 CX-5
- 2017-2018 CX-5 vehicles with VINs lower than JM3KF*****370951 (produced before Mar. 1,2018)

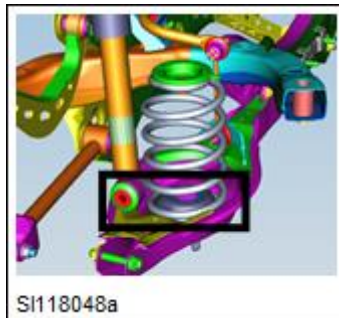
Some vehicles may exhibit a knocking noise from the rear coil spring and/or the vehicle body sits lower in the rear. These symptoms may be caused by a broken rear coil spring at its lower side.

This is caused by corrosion from dust between the rear coil spring and the spring sheet, resulting in a broken rear coil spring. To eliminate this concern, the shape of the rear coil spring has been modified. Customers having this concern should have their vehicle repaired using the following repair procedure.

1. Verify customer concern
2. Replace the rear coil spring(s) with modified one(s) according to the instructions on MGSS (REAR COIL SPRING REMOVAL/INSTALLATION).
 - Mazda3 (REAR COIL SPRING REMOVAL/INSTALLATION)
 - 2013-2016 CX-5 (REAR COIL SPRING REMOVAL/INSTALLATION)
 - 2017-2018 CX-5 (REAR COIL SPRING REMOVAL/INSTALLATION)
3. Verify repair.
