Subject: RATTLE NOISE FROM REAR OF VEHICLE WHILE DRIVING	Bulletin No.: 02-016/18
	Last Issued: 09/27/2018

2013-2016 CX-5

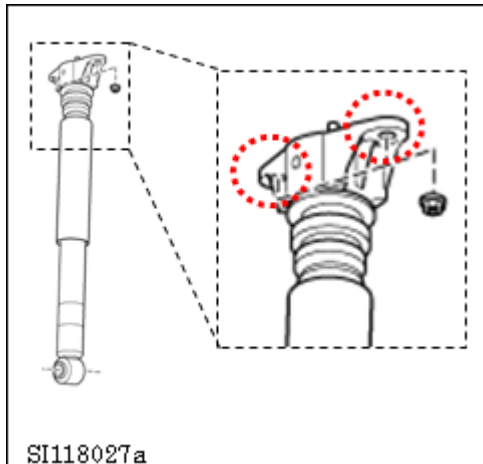
Some vehicles may exhibit a rattle noise from the rear of the vehicle while driving. The noise may be caused by a rear shock absorber mounting bracket that is heavily corroded and broken.

Due to insufficient durability of the bracket in certain environments, such as where road salt is used, corrosion and breakage can occur. To eliminate this concern, the material and the shape of the bracket (service parts) has been modified.

1. Verify the customer concern.
2. Replace the affected rear shock absorber assembly with a modified service part according to the instructions on MGSS online (REAR SHOCK ABSORBER ASSEMBLY REMOVAL/INSTALLATION).
3. Verify the repair.

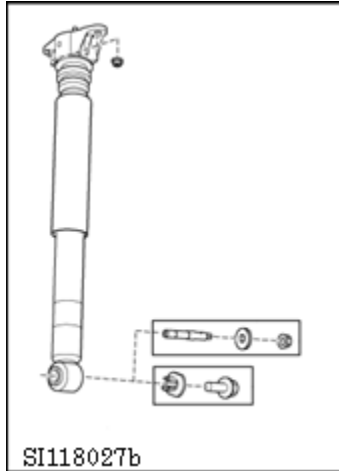
TYPE B (Nut)
TYPE A (Bolt)

TYPE	VIN Range	Production Date Range
A (Bolt)	JM3 KE**** ** 100063 - 350449	Dec. 15, 2011 - May 11, 2013
B (Nut)	JM3 KE**** ** 350450 - 921726	May 13, 2013 - Dec. 21, 2016
