Technical Service Bulletin

OIL LEAK FROM COMPANION FLANGE AREA OF TRANSFER UNIT

Bulletin No.: 03-003/18

2013-2016 CX-5 AWD vehicles with VINs lower than JM3KE*****878977 (produced before October 5, 2016)

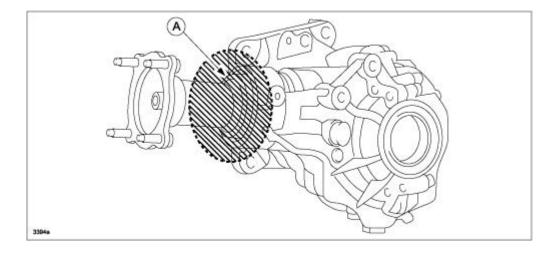
Some vehicles may exhibit an oil leak from the companion flange area (A) of the transfer unit. This concern may be caused by companion flange oil seal wear. The oil seal has been improved to increase the wear resistance.

Customers having this concern should have their vehicle repaired using the following repair procedure.
