Technical Service Bulletin

Subject: LIGHT RESISTANCE AND/OR UNUSUAL NOISE WHEN TURNING STEERING WHEEL TO THE LEFT	Bulletin No.: 06-002/18
	Last Issued: 09/14/2018

2016-2018 CX-3 vehicles with VINs lower than JM1 DK**** ** 326595 (Produced before Dec. 14, 2017)

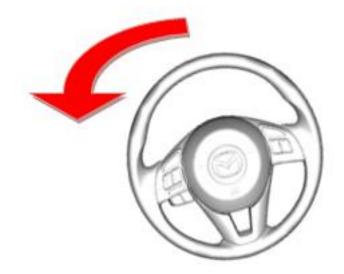
2. Inspect the label on the bottom of the steering motor. Record the 2nd, 3rd and 4th digits of the lot number.

NOTE: The red circle shown below is the steering motor part number.

Example: The lot number in the sample part below is "CE62116". The 2nd, 3rd and 4th digits are "E62".
