Technical Service Bulletin

Subject: VARIOUS ELECTRICAL SYSTEM MALFUNCTION(S) RELATED TO C-15 CONNECTOR CORROSION	Bulletin No.: 09-036/18
	Last Issued: 09/20/2018

2013-2015 CX-5 vehicles with VINs lower than JM3KE*****554564 (produced before Nov. 24, 2014)

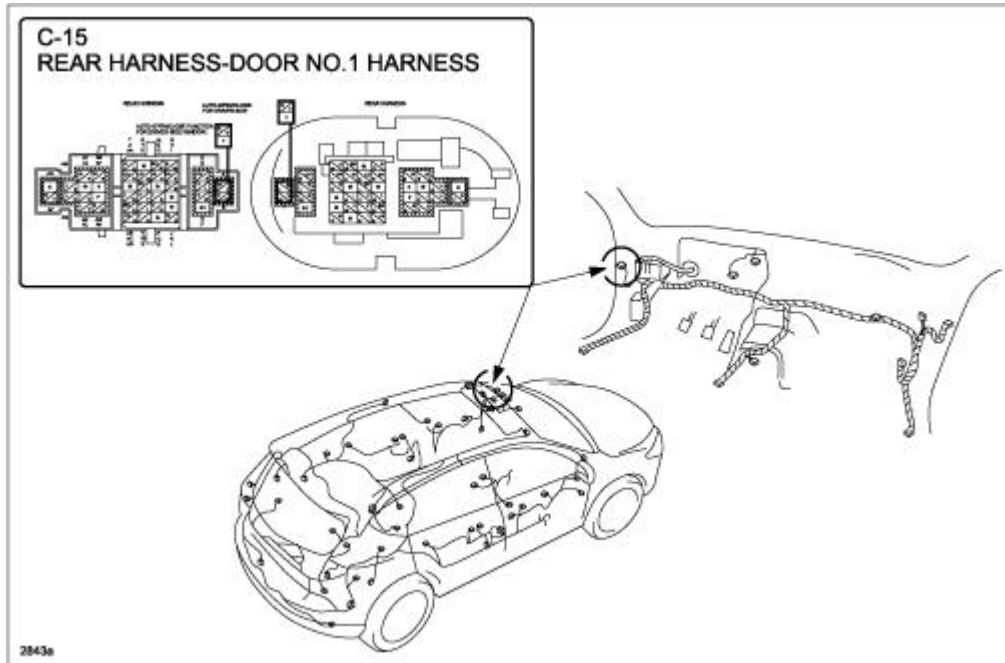
The symptoms listed above may be caused by corrosion of the C-15 connector terminals due to water intrusion through the front door. In low ambient temperatures, the door harness hardens. If the door is fully opened, it may create a gap between the door and the door harness grommet, which may allow water to enter through the gap.

- The front door harness grommet has been changed to improve sealing performance.
- Holes inside the front pillar (which are made for weight reduction), have been covered to prevent water intrusion.
- **The C-15 connector has been improved.**

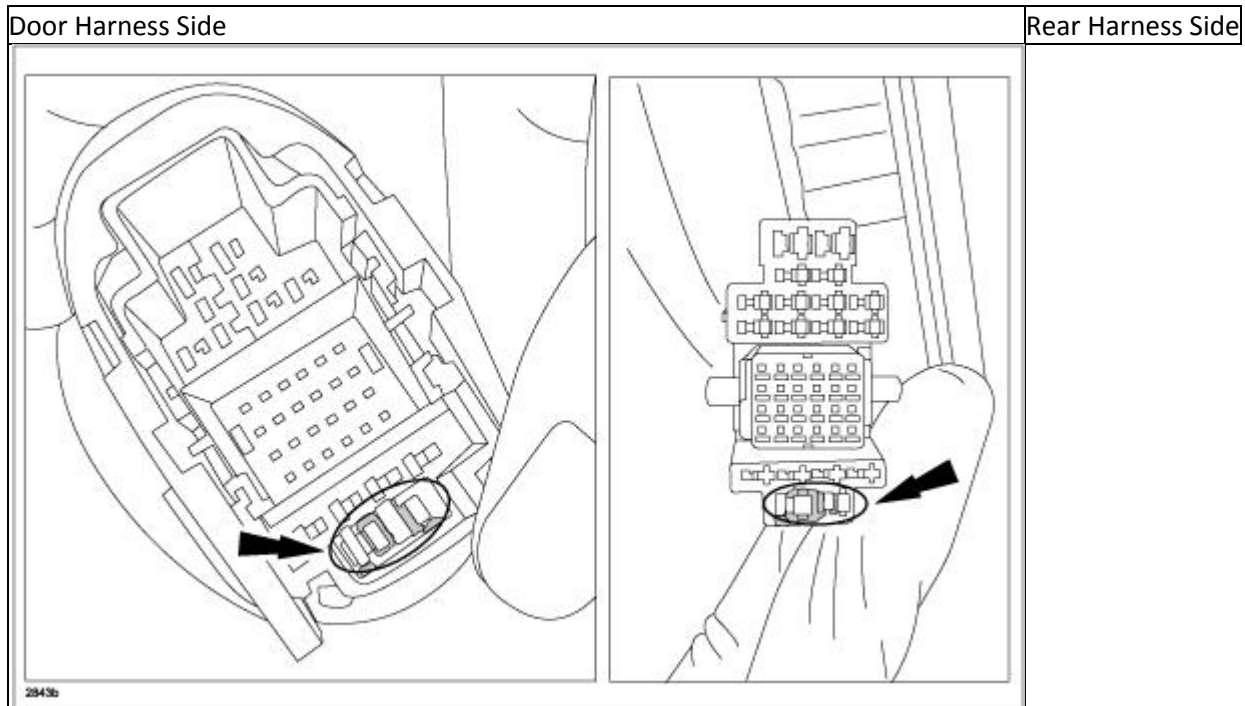
2. Record customers pre-set radio stations.
3. Slide the driver side front seat fully backwards.
4. Disconnect the negative battery cable.
5. Disconnect the C-15 connector according to the MGSS online instructions (FRONT DOOR REMOVAL/INSTALLATION).
6. Inspect for any corrosion found on the terminals shown below.

- If there is any corrosion found on the terminals, go to next step.
- If there is no corrosion found on the terminals, this bulletin is not applicable. Troubleshoot the concern(s) according to the MGSS online instructions.
