Service Alert

Subject: CAUTION WHEN PERFORMING ELECTRIC PARKING BRAKE (EPB) FORCED RELEASE PROCEDURE	Service Alert No.: SA-042/18
	Last Issued: 09/14/2018

2016-2019 CX-9

2017-2018 CX-5

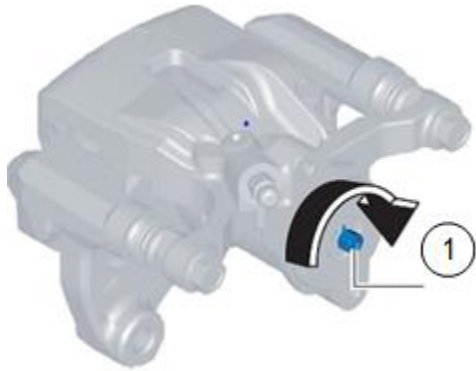
EPB FORCED RELEASE SERVICE CAUTION: DO NOT release the spindle beyond one "1" turn.

Rotate the spindle (1) one (and only one "1") turn in the direction of the arrow shown to release it. If the spindle is released too much beyond one "1" turn, the caliper may be damaged and will need to be replaced with a new one.

NOTE: The procedure on MGSS instructs you to rotate the spindle approx. 2-3 times, which is incorrect for the models specified in this TSB.

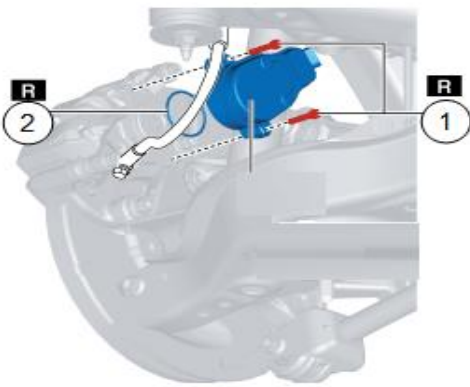
CAUTION: DO NOT reuse [R] parts

Replace the two bolts (1) and the O-ring (2) with new ones when reinstalling the EPB Motor Gear Unit.
