**MODEL:** Karma Revero**DATE:** June 2018**TITLE:** Body Harness Splice Location Inspection**First Release****PRIORITY:** On complaint**APPLICABILITY:** See VIN list**MARKET REGION:** North America**PURPOSE:** Remedy persistent and unique trouble code set.

**TITLE: Body Harness Splice Location Inspection**

**TB-18-90-02**

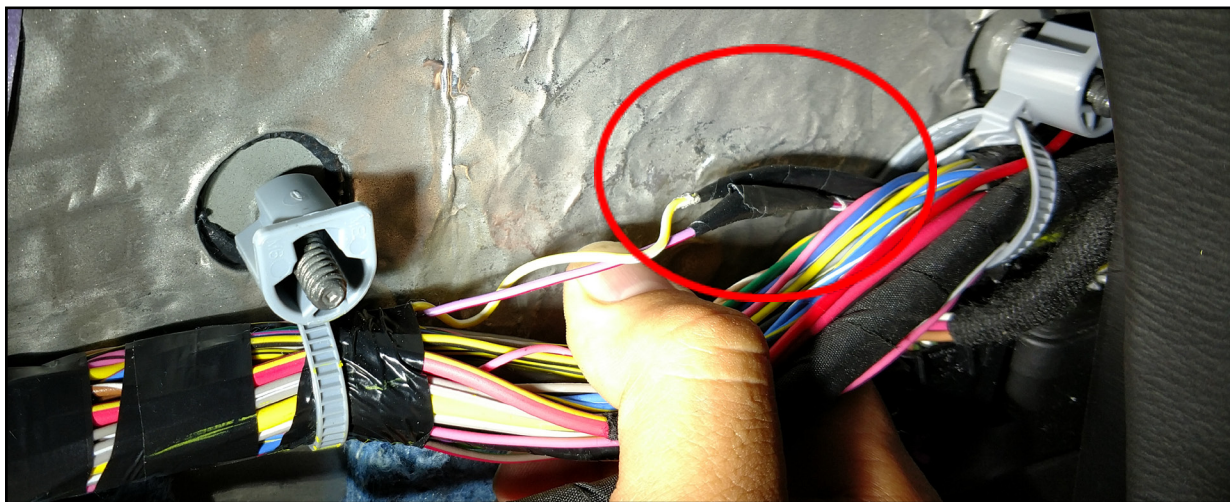
fig.1

The body harness will need to be inspected. and any bare wires at the splice location will need to be wrapped appropriately with electrical tape to protect from an electrical short condition. Proper splice shown (fig.1).

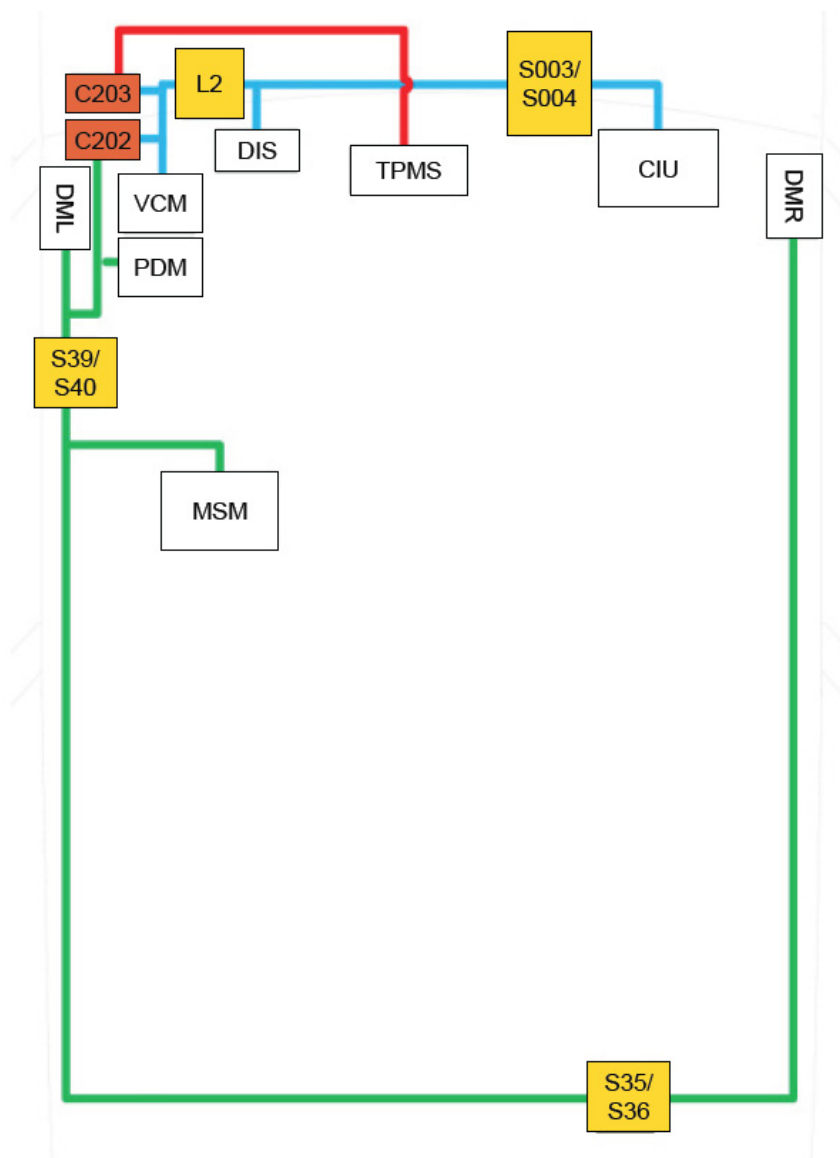
fig.2

The splice locations can be found in the Connector Manual (C1810ASD5106) available on the Retailer Service Web Portal. The body harness is shown on (fig.2) as this is the area of concern.

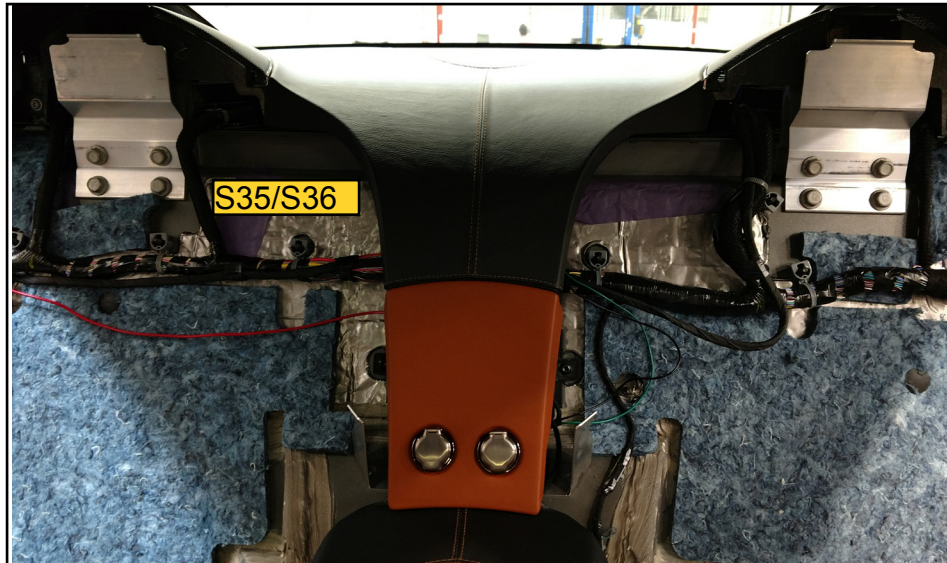
fig. 3

Begin with inspection of splice S35/S36 (fig.3), this will require removing the rear seat backs.

IF the electrical short condition is not found inspect splice S39/S40 for the same condition, wrap the wires as needed to protect from an electrical short at this location.

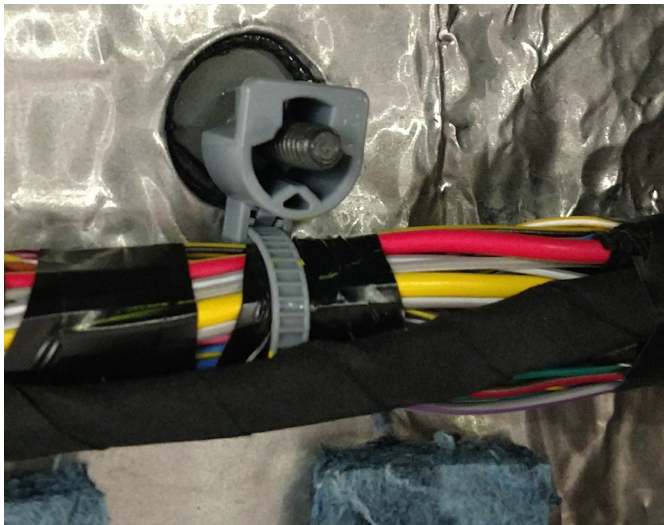
fig. 3a

The splice was found in (fig.3a) and wrapped as shown in (fig.3b).
