Ryan told Bill Gallagher that the retail customer had complained that there were no screws in the roof. Bill assured him that this was not standard practice and would investigate the issue and respond to Ryan with a report on the trailer in question. VIN: 53BLTEB27KA043426 Model: APCH85X26TE3

In the investigation of the trailer, multiple issues were discovered:

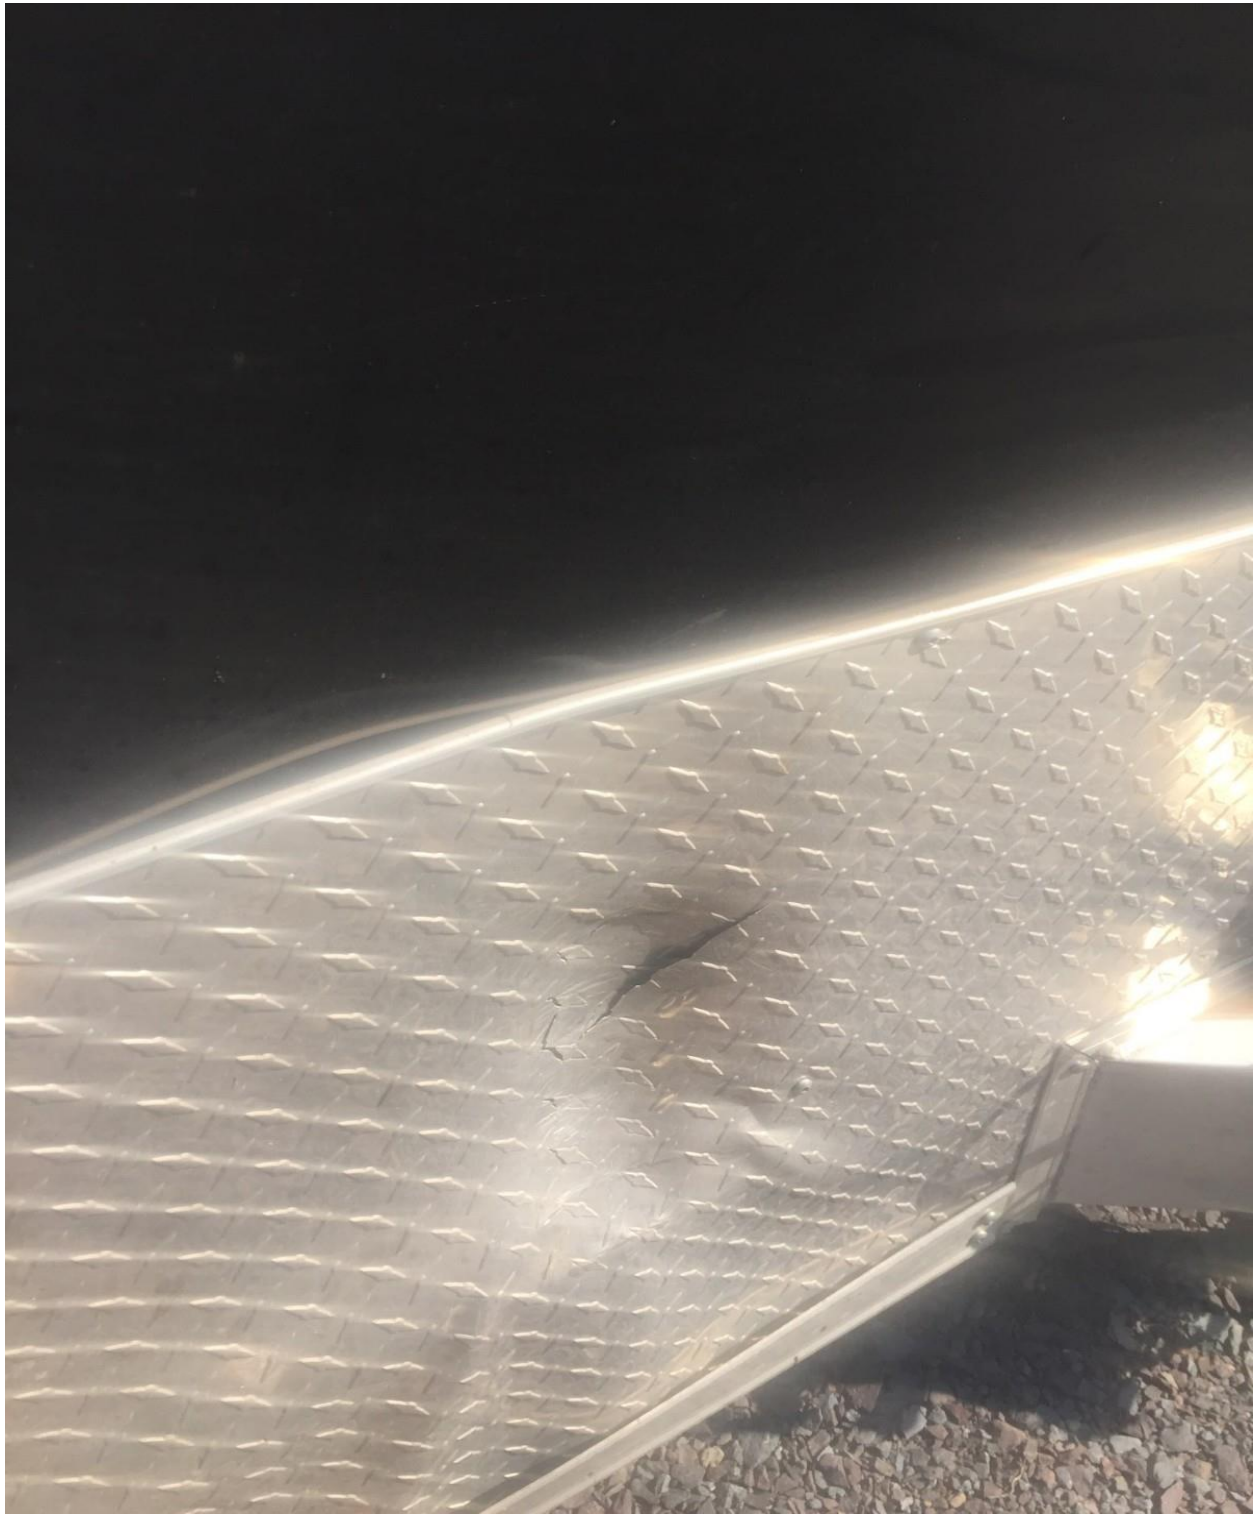
1a.

1. There were at least two times that the trailer was jackknifed to the point that the front stone guard was damaged. (1a-1b) The stone guard showed damage to both the road side and curbside of the A-frame. This type of damage occurs when the tow vehicle's bumper contacts the front of the trailer in either a sharp turn going forward or when the trailer is being backed and it is maneuvered into an extreme angle with the tow vehicle.

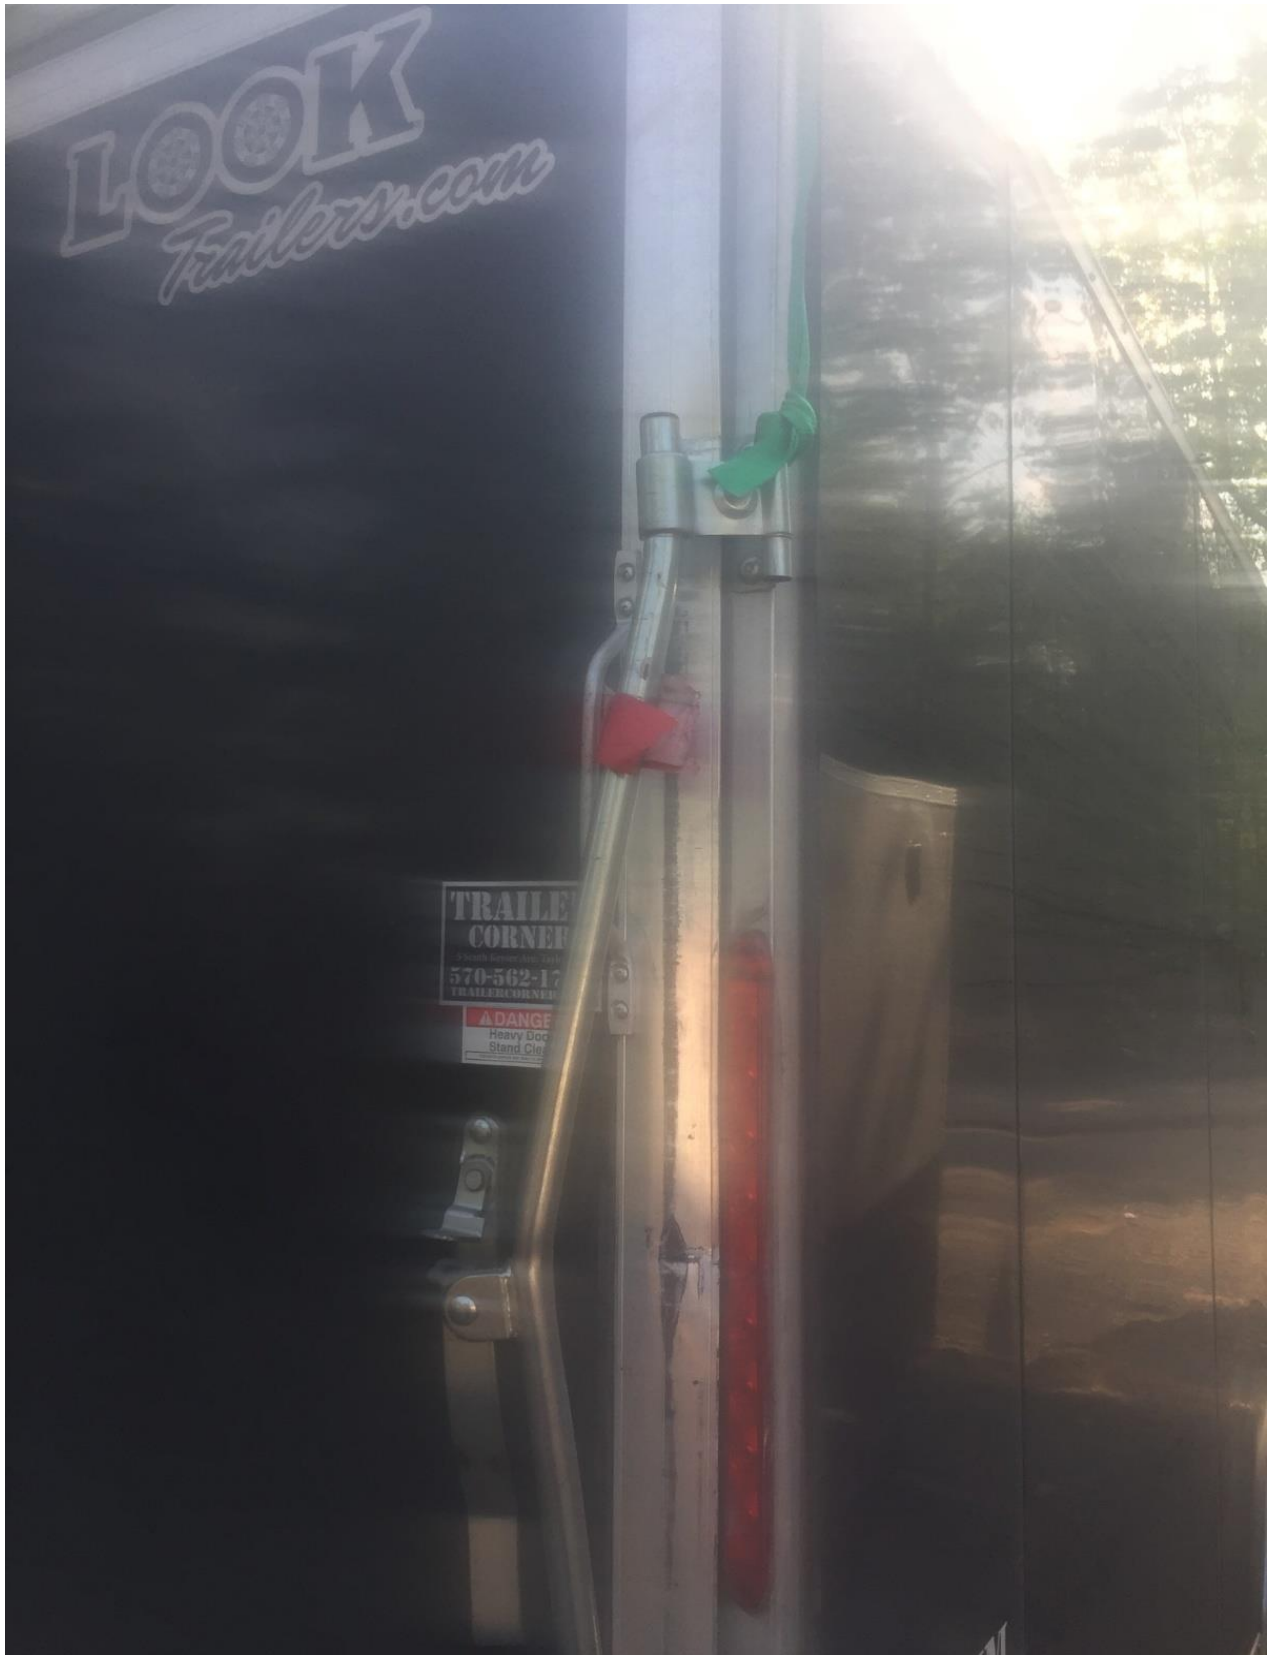
2a.

2. The bar locks were damaged to the point that they would not hold the rear ramp door shut properly. (2a) This usually occurs when the load inside the trailer comes loose and impacts the door. The customer admitted to Bill Dewey that their ATV (2b) had, in fact, hit the rear ramp door causing the damage.

A new roof has been applied to the trailer using the best practice. Since there was a safety concern due to the damaged bar locks on the ramp door, both bar locks were replaced. The customer picked his trailer up from the manufacturing plant on Monday 8/20/2018 and was satisfied with the repairs.

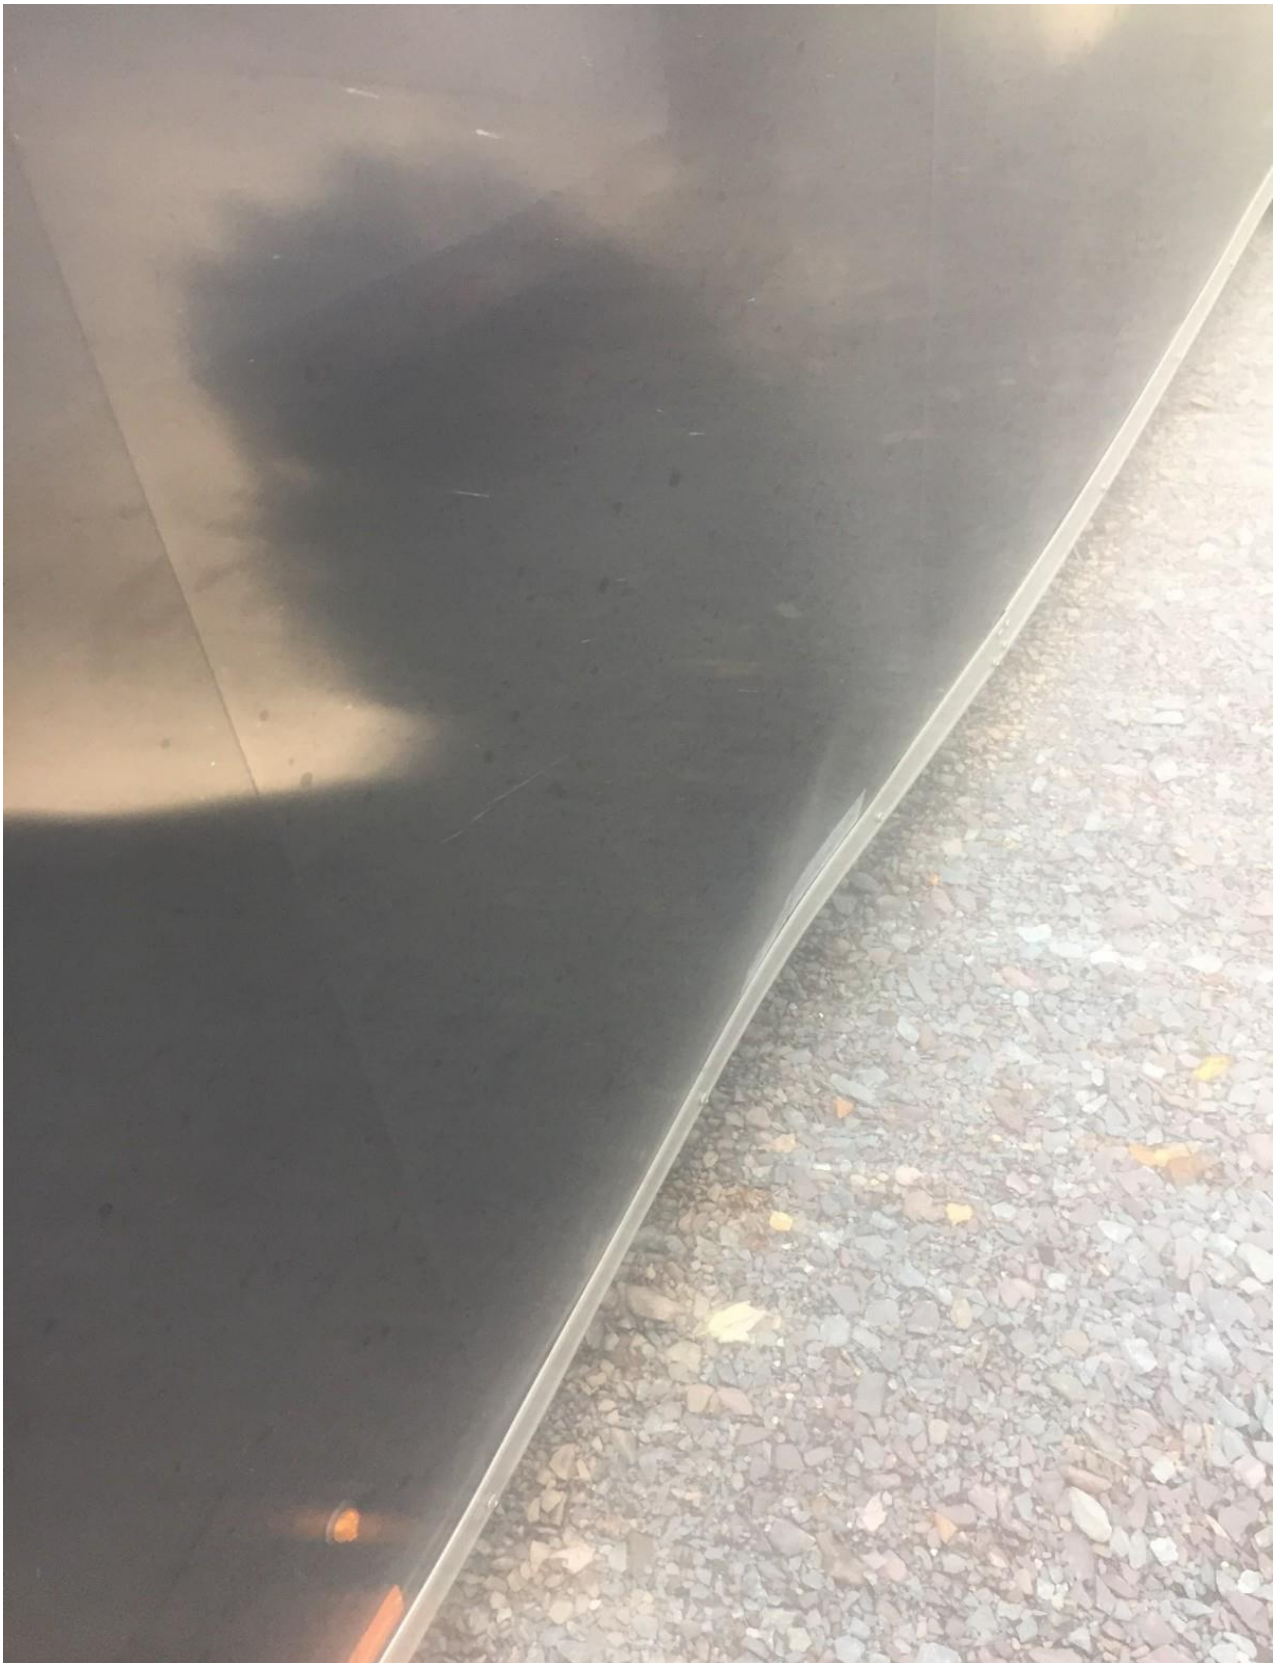
3a.

3. There is damage to the bottom trim and skin on the side of the trailer as well, apparently from an impact. (3a)
4. The roof did peel from the front to the back approximately three quarters of the way back. (4a)

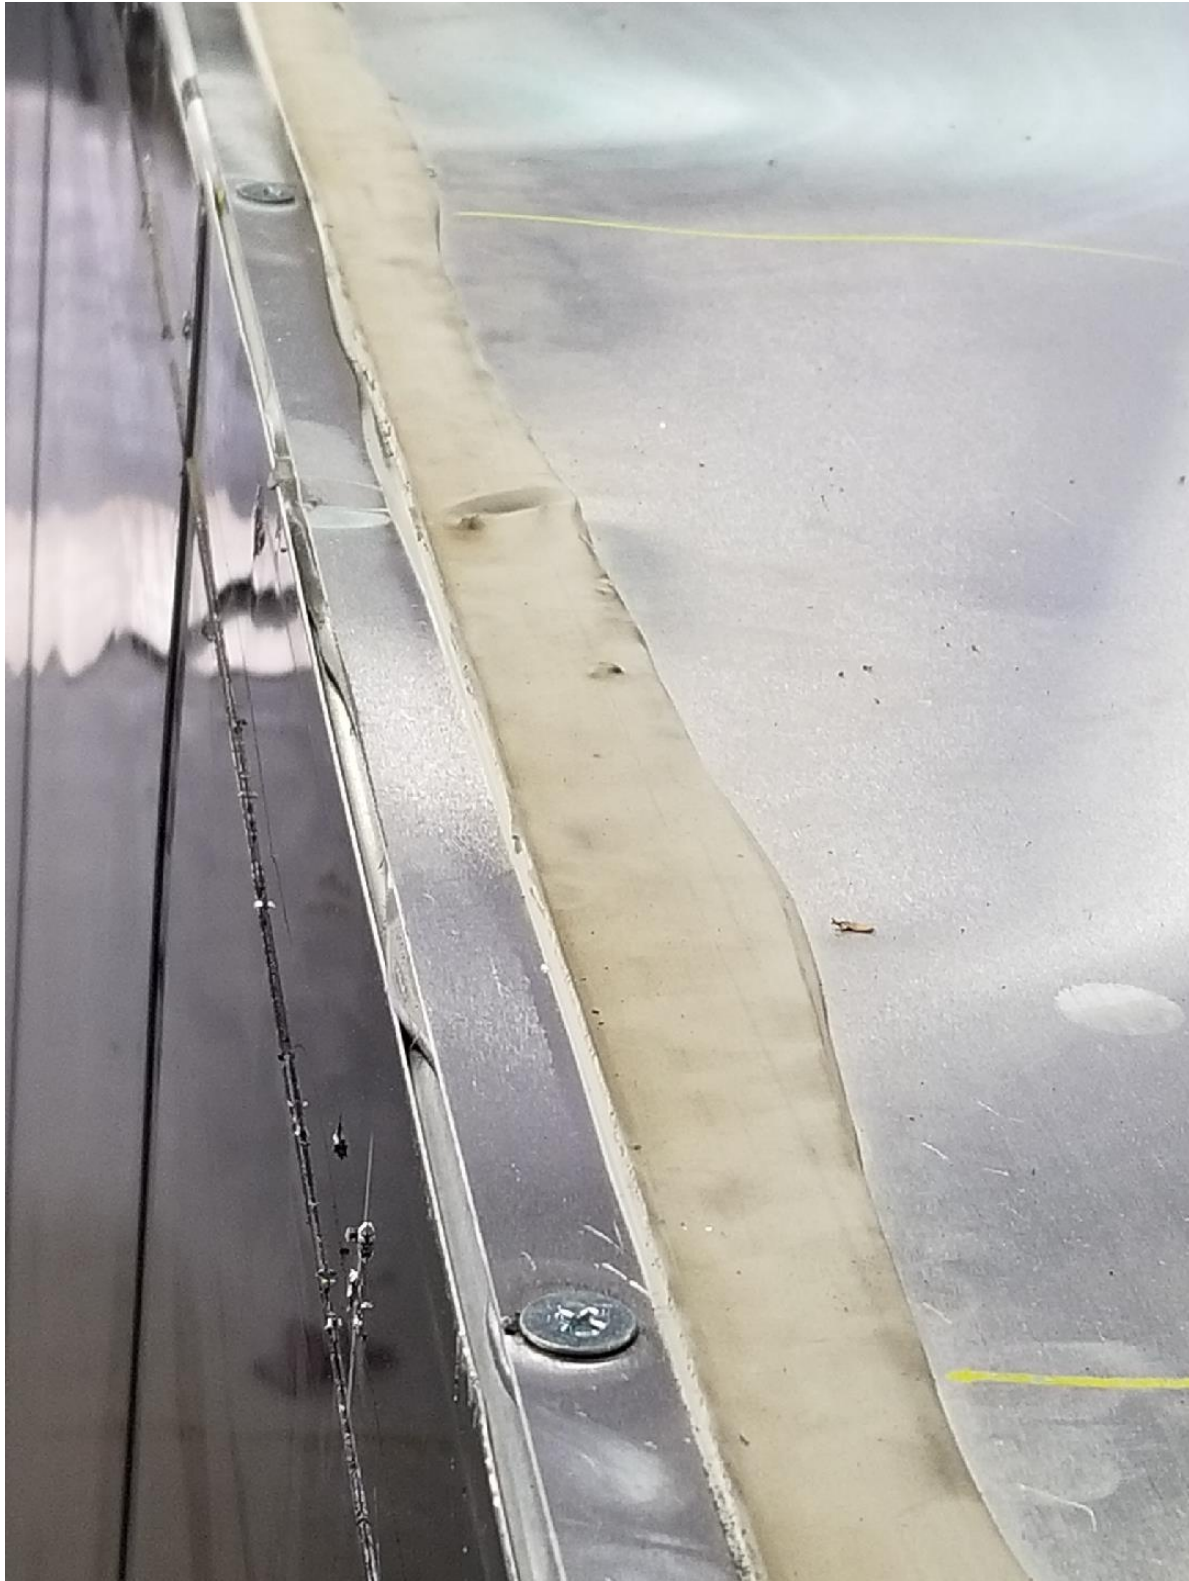
5a.

The best practices were followed with this trailer with the exception of one step. The screws were not applied in the prescribed six inch pattern; they were further apart at about twenty inches. (5a) Under normal operating conditions this should have been adequate to maintain the roof, but with the abuse the trailer had experienced, additional stresses were placed on the entire structure of the trailer that could have contributed to the separation of the roof.
