SI B11 06 18
Engine

TURBO BOOST ACTUATOR ROD LOOSE (DIESEL)

With the N47T or N57T Diesel Engines

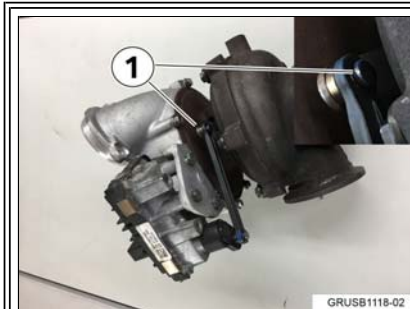
Limited engine performance (lack of boost) with a Malfunction Indicator Lamp (MIL) illuminated.

- 244C00 - Boost pressure control, control deviation: charging pressure too low/positive deviation

The clips that hold the boost actuator rod for the variable nozzle technology (VNT) turbo have come loose (1).
