SI B51 09 18
Body Equipment

G01 RUBBING/SCRAPING NOISE WHEN TURNING THE STEERING WHEEL

G01 (X3) produced up to 6/1/2018			
----------------------------------	--	--	--

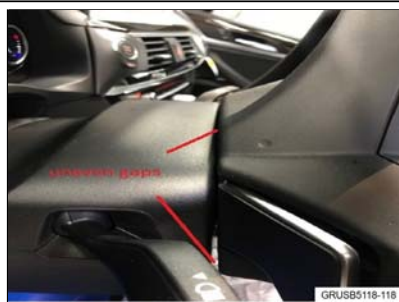
1. Perform a visual inspection of the steering column shrouds.

Inspect for uneven gaps between the steering column shrouds and the steering wheel.

Do the gaps appear uneven as seen to the left?
