SI B54 05 18  
Special Roofs

## RATTLE NOISE FROM FRONT OF PANORAMIC ROOF WHILE DRIVING OVER ROUGH ROADS

F48 (X1) produced up to 3/31/2017		
--------------------------------------	--	--

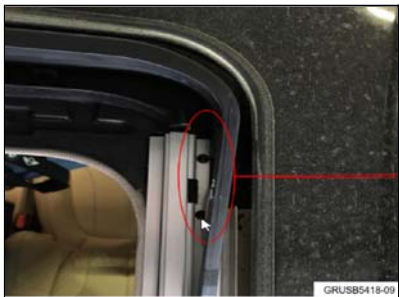
While driving over rough roads, a rattle noise may develop from the front corner areas of the panoramic sunroof.

Loose or under torqued bolts for the panoramic sunroof frame.

1. Open the panoramic sunroof to gain access to the front corner areas of the sunroof frame.

2. Torque all 4 (2 per side) of the panoramic sunroof bolts, as seen to the left, to exactly 3.5nm.
	3. Retest the vehicle to verify the noise is no longer present.
