SI B61 11 16  
General Electrical Systems

## THE CHARGING CABLE DOES NOT RELEASE FROM THE CHARGING SOCKET AFTER CHARGING

This Service Information bulletin supersedes SI B61 11 16 dated **September 2016**

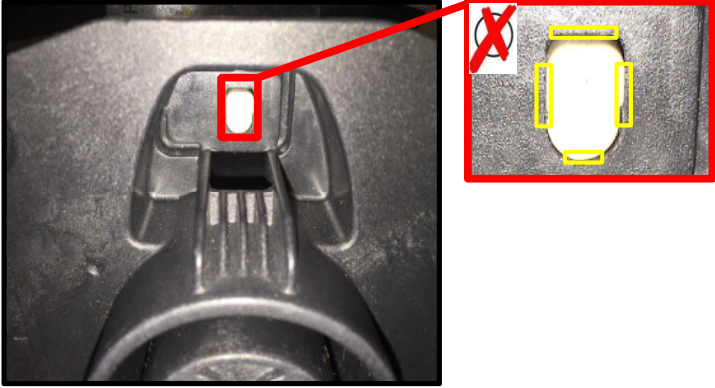
High voltage charging socket housing tolerance prevents the lock actuator pin from mechanically disengaging from the charging cable.

| | <ol style="list-style-type: none"><li>1. Visually inspect the actuator lock pin to see if it is binding in the hole in the highlighted areas as shown. The actuator pin should move easily when activated.</li><li>2. Did you find evidence of binding?<br/>YES- continue with Step 2.<br/>NO – diagnose with ISTA for charging system-related faults.</li></ol> |
