TIS Service Bulletin Page 1 of 6

FOUL, MUSTY ODOR FROM HVAC: WET FOOTWELL CARPET

This Service Information bulletin replaces SI M64 01 11 dated October 2017.

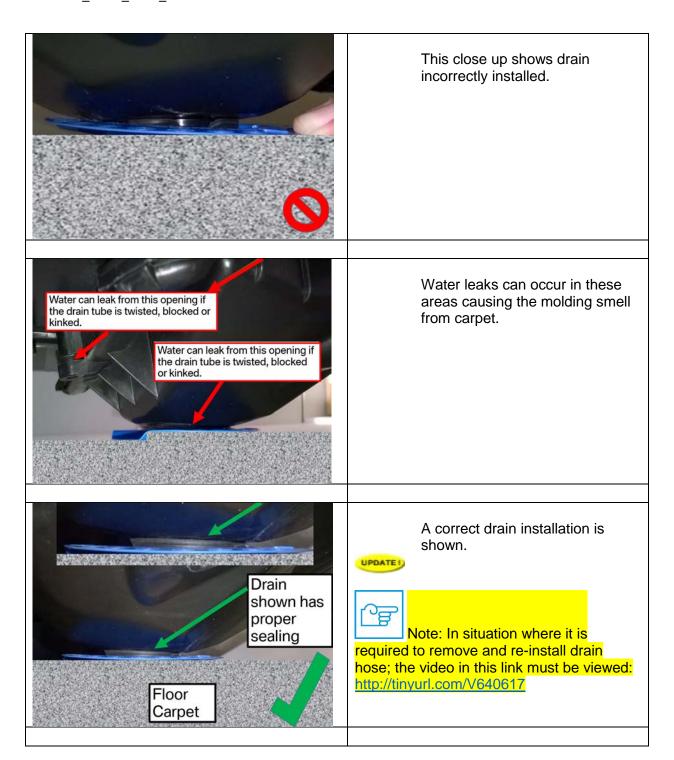
The condensate drain hose is not properly draining the condensate from the vehicle.

Drain shown is twisted and deformed.

NO – Prepare a new drain hose for installation as shown in the next step.

- 3. Before installing new drain, lubricate (silicone spray) top of drain shown by the yellow ring.
- 4. Make sure the drain is not deformed and install parallel to the floor and carpet.

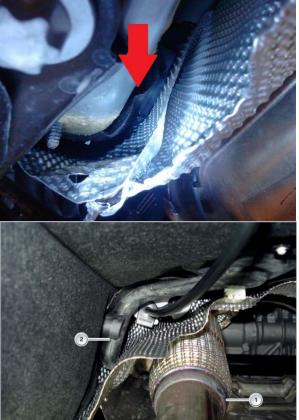
- ii. Remove the clamp and support exhaust to expose the drain.
 - The exhaust heat shield must not squash or damage the protruding condensate drain hose.
 - There must be clearance between the heat shield and the drain (2).

i. remove brackets (1) and heat shield screws (2) and (3) above exhaust.
