## COMPONENT PROTECTION ACTIVE. HEAD UNITS CANNOT BE SWAPPED BETWEEN VEHICLES FOR TESTING.

This Service Information bulletin supersedes SI M65 06 17 dated March 2018.

# Release Notes Programming

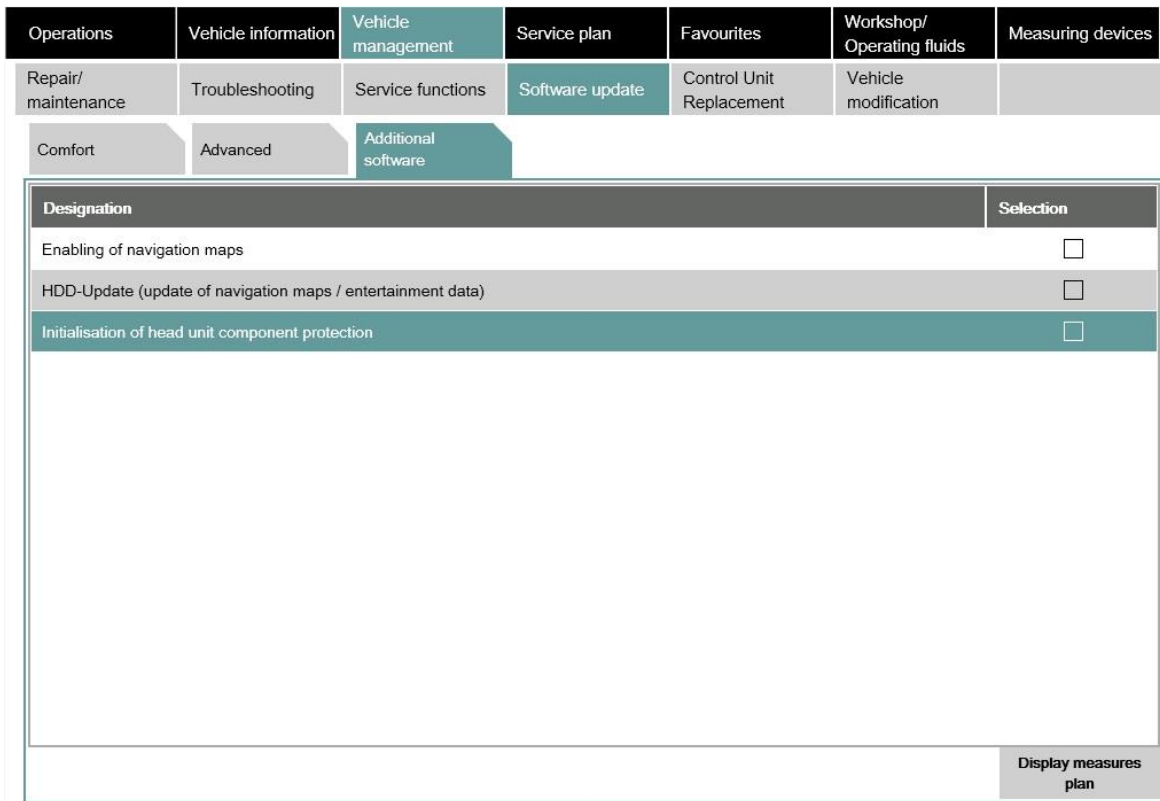
If the component protection was activated, the fault memory 0xB7F87A "component protection active" is set, and the enabling codes of the HU-H2 become invalid.

2. Contact Technical Support via PuMA, who will generate the required enabling codes for the head unit.
3. Connect the vehicle and select the initialisation for the component protection function in the Additional software tab.

4. Confirm the dialogue to download enabling codes.
5. Confirm deblocking of the component protection.
