AIR BAG LAMP ILLUMINATED. FAULT CODE 9309A0

This Service Information Bulletin supersedes SI B61 27 17 **dated April 2018**.

F15 (X5 40e)

PHEV vehicles with N20 engine

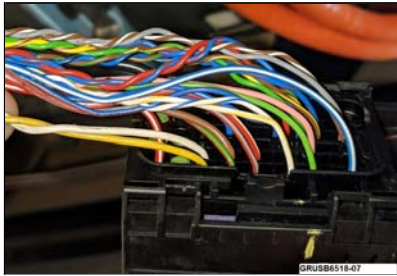
The wires going to pins 7 (CRASH +) and 20 (CRASH-) in connector A190*1B are under tension. Vibrations may sporadically increase the resistance values of these connections outside of the acceptable range leading to an air bag warning light being illuminated.

<p>10. These two wires need to have some tension relieved on them. Remove the last 8" of tape from the harness at the EME connector to introduce some stress relief into this connection at the EME.</p> <p>Here you can see the two wires white and Yellow are under tension</p>

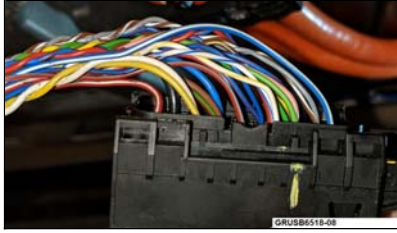
<p>11. The wires between the zip tie location and the EME electrical connector/pins should NOT be under tension!</p> <p>Here you can see the wires have a strain relief loop to eliminate tension on the electrical pins</p>
