TIS Service Bulletin Page 1 of 2

# FALSE WARNINGS THAT THE FRONT PASSENGER SEAT IS OCCUPIED WITHOUT THE SEAT BELT BUCKLED

This Service Information bulletin supersedes SI B72 04 17 dated February 2018

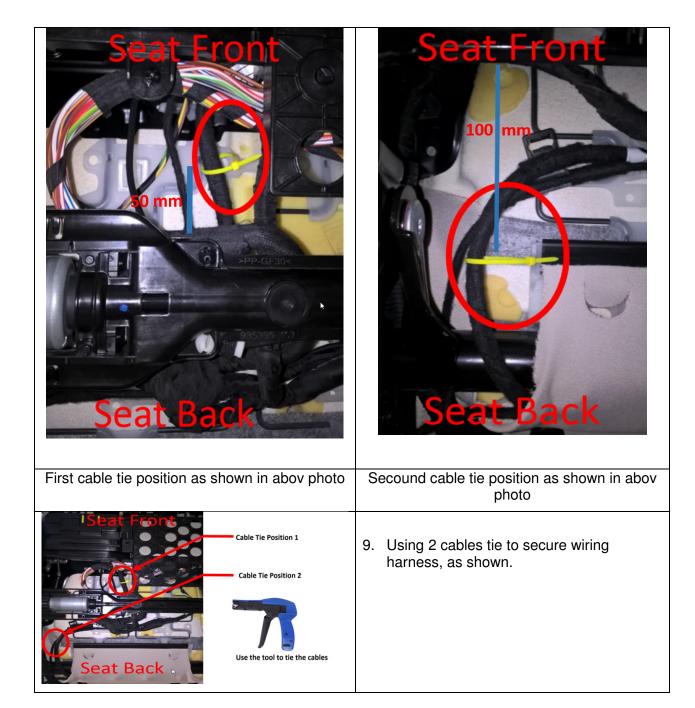
SI B72 04 17Attachment

- 1. Electronics (for example smart phones or laptops) are connected to the USB charging port or cigarette lighter and placed on the seat.
- 2. Faulty plug connection to Evaluation Electronics (CIS).
- 3. Unsecured seat harness under the seat.

8. Secure the loose clip attached to cables, as shown.

- 10. Re-attach seat trim panel.
- 11. Verify free motion of seat belt and seat adjustment.
- 12. Verify correct operation of occupant detection system. There should be no fault memory entries for airbag warnings.
- 13. Check the POL function
