PROPER COOLANT BLEEDING PROCEDURE (I12)

I12 (i8)	I15 (i8 Roadster)
----------	-------------------

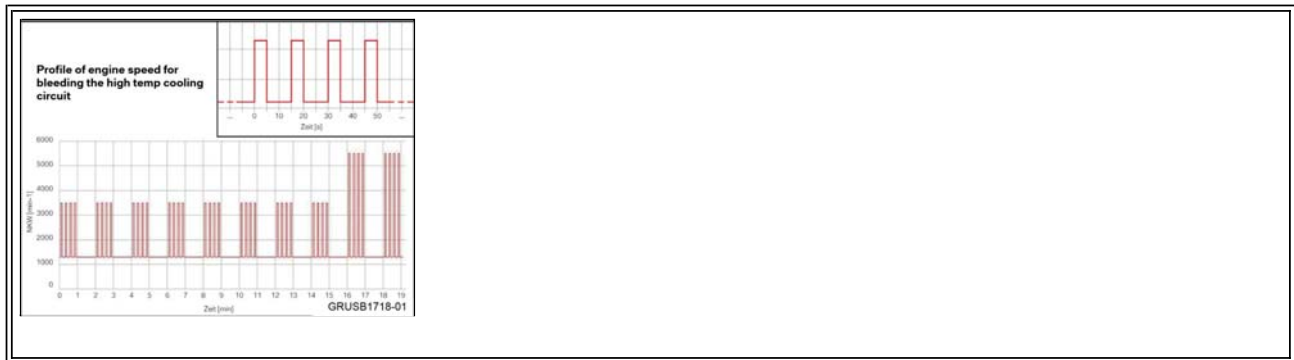
- Cooling system bleeding
- Bleeding high-temperature coolant circuit: „ABL-DIT-AS1214_BX8_ENTKUEHL“

NOTE: The on throttle/off throttle steps in this test plan must be carried out exactly as described/indicated.
