LIN BUS FAULTS WITH EXTERIOR REARVIEW MIRROR GLASS DAMAGE

F39 (X2)

Produced up to 4/2018

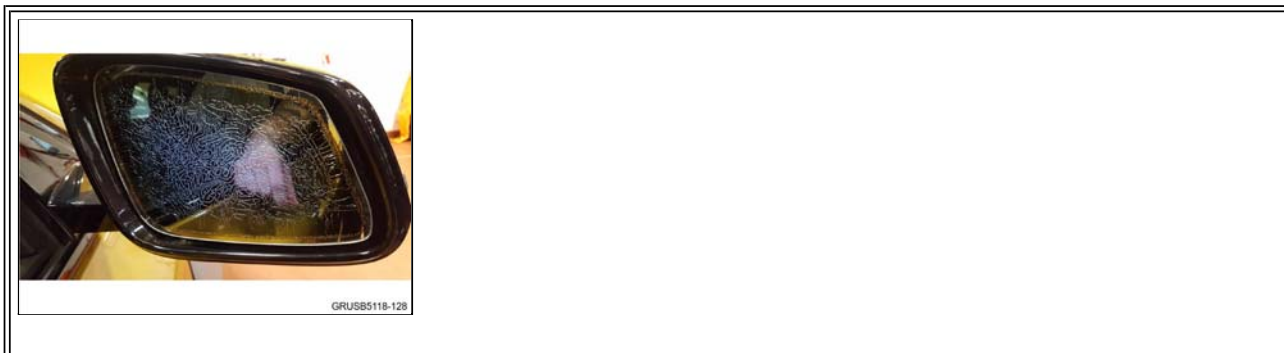
The exterior rearview mirror glass is discolored or cracked. The power windows and folding mirrors may not operate, and one or more of the following LIN bus faults are stored in the BDC (Body domain controller):

Faulty exterior rearview mirror electronics have created a short on the LIN bus, damaging the mirror glass and causing functional errors in power window and exterior mirror operation.

Replace the complete mirror assembly on the affected side, which includes replacement mirror electronics.
