SI B51 14 18
Body Equipment

RATTLE NOISE FROM DOOR WHEN CLOSING

F22 (2 Series Coupe)	F23 (2 Series Convertible)	F87 (M2)	
----------------------	----------------------------	----------	--

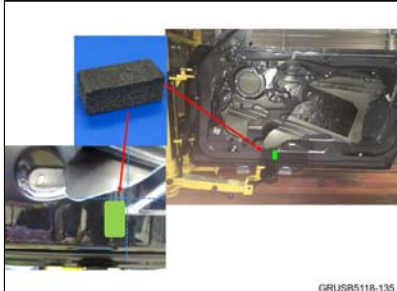
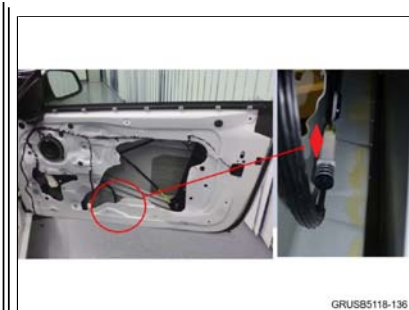
The window regulator drive cable is resting against the inside of the door, and can rattle or buzz when the door is closed.

Note: The photos to the left show the general location for installation of the sound insulation foam. The foam will be installed **inside** the door cavity, between the regulator cable and door.

<ol style="list-style-type: none"> 3. Peel off the adhesive backing and install sound insulation foam PN 51 13 8 209 642 on the inside of the door cavity, preventing the white plastic portion of the regulator cable from resting on the door.
