SI B54 06 18  
Special Roofs

## SERVICE ACTION: CHECKING AND, IF NECESSARY, REPLACING CONVERTIBLE TOP LOCKING BASE PLATE

This Service Action involves 77 I15 (I8 Roadsters) produced from 3/6/2018 to 5/14/2018.

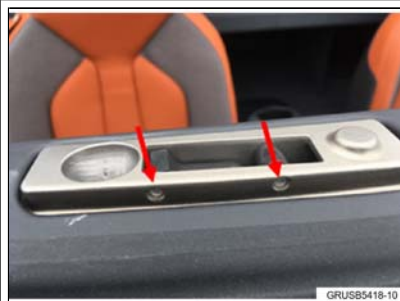
1. Lower the convertible top to inspect both convertible top locking base plates above the windshield.

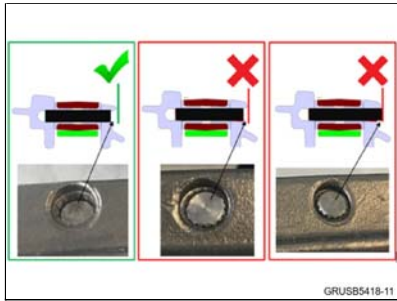
The knurled bolts on the convertible top locking base plates may not have been installed correctly on the cowl panel.

The knurled bolts may not have been pressed completely into the base plate.

2. Inspect the installation of the knurled bolts of both base plates. Reference the photo to the left for examples of faulty bolt installation.

Are all 4 knurled bolts correctly pressed into both base

Inspect the knurled bolts for correct installation on both the right and left base plates on the upper cowl. If the knurled bolts are not correctly installed, replace the affected base plate.

| <p>GRUSB5418-11</p> | <p>plates?</p> <p><b>YES:</b> No further repair is needed.</p> <p><b>NO:</b> Continue to step 3 to replace one or both base plates.</p> |
