STEERING WHEEL BUTTONS DO NOT FUNCTION RELIABLY

This Service Information bulletin supersedes SI B61 24 17 **dated May 2017**.

F22 (2 Series Coupe)	F23 (2 Series Convertible)	F30 (3 Series Sedan)	F31 (3 Series Sport Wagon)
F32 (4 Series Coupe)	F33 (4 Series Convertible)	F34 (3 Series Gran Turismo)	F36 (4 Series Gran Coupe)
F80 (M3 Sedan)	F82 (M4 Coupe)	F83 (M4 Convertible)

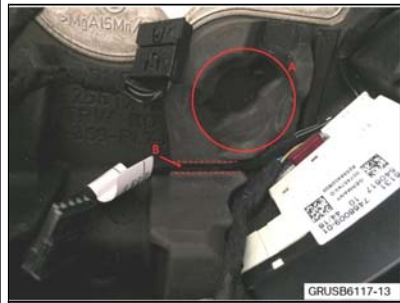
1. Keep the area of the airbag counter piece area (A) clear to avoid the risk of crushing the harness. Be certain to use the routing guides (B) to run the cables.

Note: Be certain to correctly route the wiring for the steering wheel connecting line as shown below.

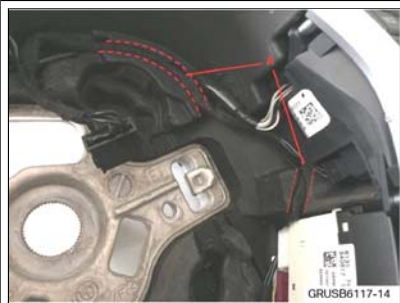
2. Be certain to use the routing guides (A) to run the cables.

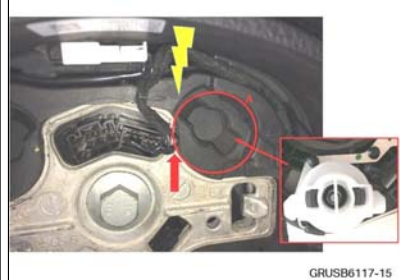
3. Keep the area of the airbag counter piece (A) clear to avoid the risk of crushing the harness.

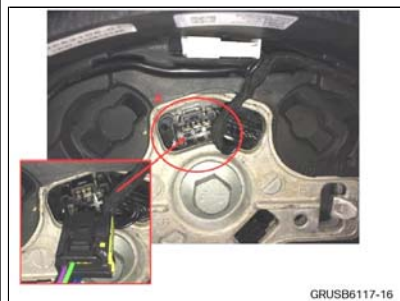
4. Keep the area of the cable connection clear (A).
