SI B62 08 18
Instruments

INSTRUMENT CLUSTER DISPLAY SHAKES-SHIFTS TO THE LEFT

G01 (X3)	G30 (5 Series Sedan)	G32 (6 Series Gran Turismo)	
----------	----------------------	-----------------------------	--

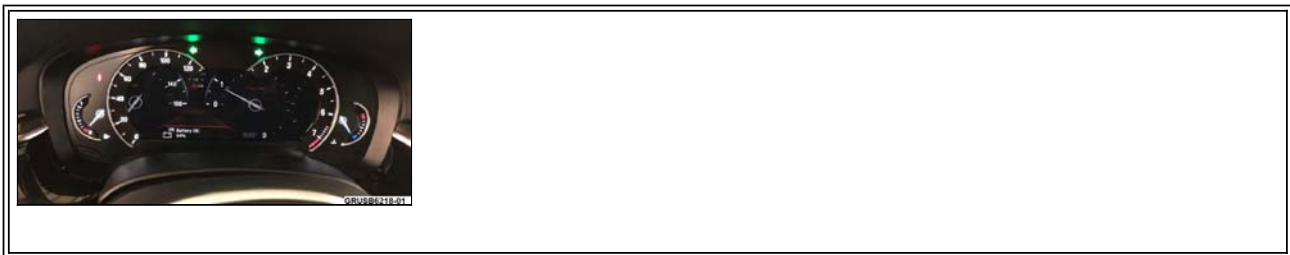
The Instrument cluster intermittently flickers, shakes and has shifted to the left.

The fault is resolved once the vehicle goes into sleep mode.

The fault can reoccur at any point.

Problem with the contact at the Automotive Pixel Link connection plug on the instrument cluster.

Software error in the instrument cluster.

Reprogram the vehicle with ISTA 4.14.1x or higher.

Vehicles produced up to 01/31/2018
Replace the instrument cluster then program the vehicle to ISTA 4.14.1x or higher. Target I Level S15A-18-11-500

Vehicles produced after 02/01/2018:
DO NOT replace the instrument cluster. Program the vehicle to ISTA 4.14.1x or higher. Target I Level S15A-18-11-500
