## ENGINE CRANKS, NO START AND/OR ENGINE COOLANT TEMPERATURE FAULTS

This Service Information bulletin replaces SI M17 01 15 dated **March 2015**

R55 (Cooper S Clubman)	R56 (Cooper S)	R57 (Cooper S Convertible)	R58 (Cooper S Coupe)
R59 (Cooper S Roadster)	R60 (Cooper S Countryman)	R61 (Cooper S Paceman)

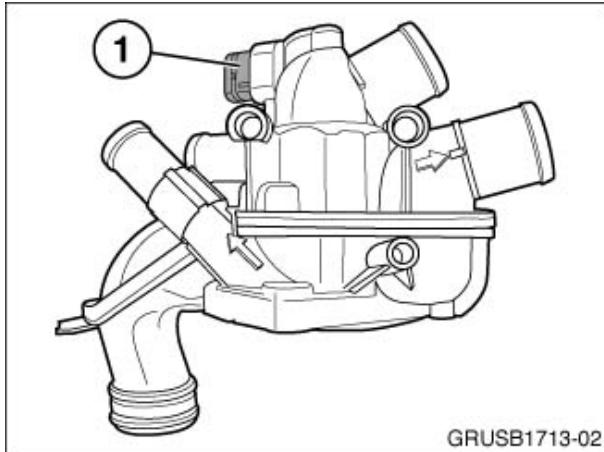
**Early version thermostat and temperature sensors**

N18 engines up to July 1013 production were equipped with the thermostat P/N 11 53 7 588 876 or 11 53 7 647 305. These thermostats are identified with a single, four-pin connector on the thermostat housing. The temperature sensor is integrated into the thermostat housing (1). This temperature sensor is not replaceable.

The early version of the N18 built from August 2010 (the start of N18 production) to March 2013 also fell under the following engine temperature sensor Service Actions. Check the B-pillar for label code number 53 (Service Actions M17 06 12, M17 07 12, M17 08 12 and M17 09 12) or label code 60 (M17 02 13). These Service Actions were to install a remote engine temperature sensor to eliminate the temperature sensor integrated into the thermostat (see the illustration below). Also check to see if the vehicle is affected by one of these Service Actions by checking the "Service Menu" of DCSnet (Dealer Communication System) or with the Key Reader. If the DME has faults stored related to engine temperature, perform the necessary Service Action.

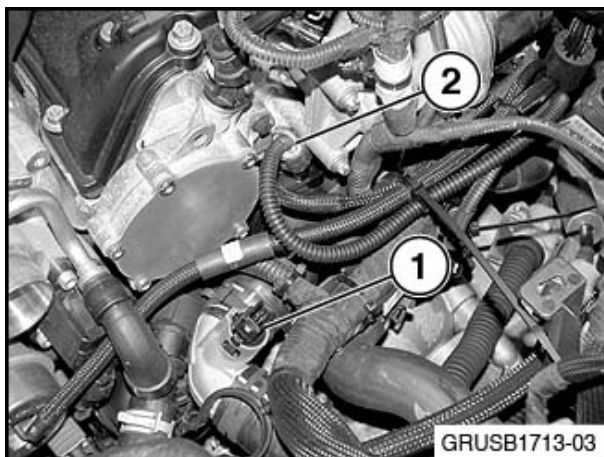
Checking for Service Action: The first version of the Service Action instructed the technician to install a remote temperature sensor inline of the upper coolant hose, coming off the thermostat (1). A later version of the Service Action had a remote temperature sensor installed in the thermostat bleeder screw (2). It is possible that both sensors are installed on the engine. Only the bleeder screw-type sensor should be wired into the engine harness in these situations. (See the attachment Installing Temperature Sensor for installing the 13 62 8 603 908 temperature sensor.)

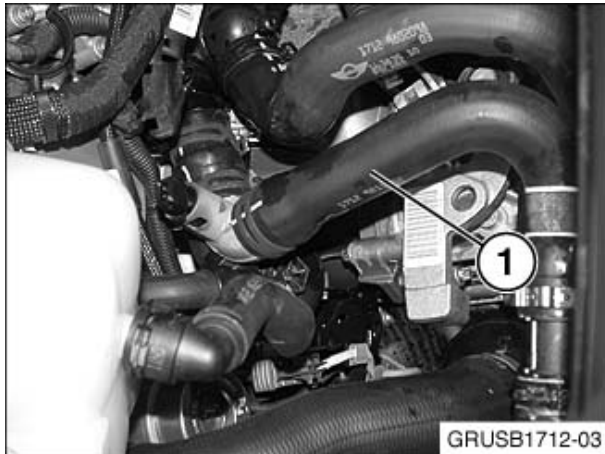
The remote coolant temperature sensor (1) was also used in production on N18 engines built from March 2013 until July 2013. This temperature sensor is no longer available as a spare part. The screw-in sensor for the bleeder screw will also not fit as a replacement part for N18s in this production range. If, during diagnosis, it is determined that this style sensor has failed, the thermostat would need to be replaced (see the Late Version thermostat below).

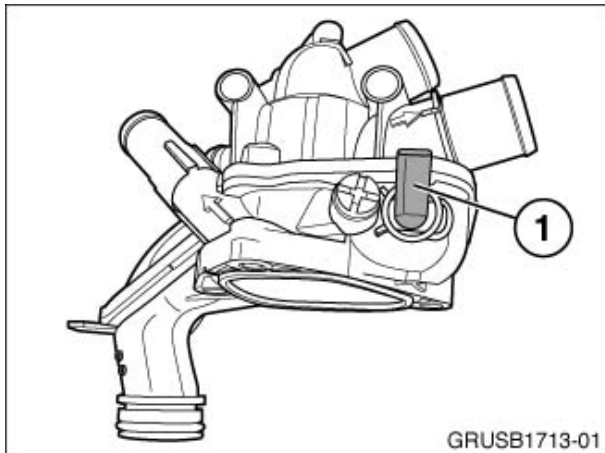
### Late version thermostat and temperature sensor

Thermostat P/N 11 53 7 647 751: This thermostat was used in production from July 2013 onwards. This thermostat can be identified by a low profile and replaceable temperature sensor (1). The sensor can be ordered using P/N 13 62 8 602 086.

**Note:** This thermostat is now also used as the replacement part for all N18 engines. An adapter harness will be needed to retrofit this thermostat into cars built before July 2013. Refer to the Parts information section of this bulletin for details.

**Note:** This thermostat is not designed to work with a 13 62 8 603 908 (bleeder screw) temperature sensor.
