SI M54 01 18  
Special Roofs

July 2018  
Technical Service

## SUNROOF WILL NOT CLOSE

| F54 (MINI Clubman) | F55 (MINI Hardtop 4-door) | F56 (MINI Hardtop 2-door) | F60 (MINI Countryman) |

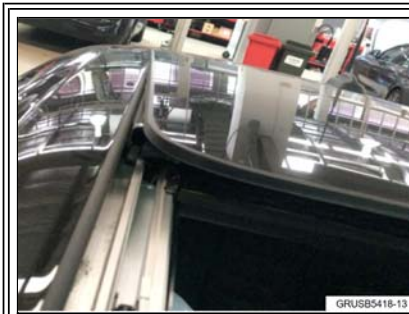
The sunroof glass will not close, and the sunroof glass panel may appear twisted in the roof frame.

The cable drive mechanism for the glass sunroof panel has broken.

Clean the sunroof frame of any debris and replace the sunroof drive cable mechanisms.

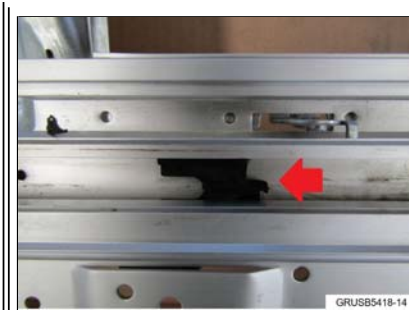
| | <ol style="list-style-type: none"> <li>2. Inspect the drive cable mechanism for damage or broken components in the sunroof tracks. If any debris or broken components are found in the sunroof tracks, they must be</li> </ol> |

cleaned completely.

Note: If a damaged drive cable mechanism is found, the complete sunroof frame does **NOT** need to be replaced, only the cable mechanism.

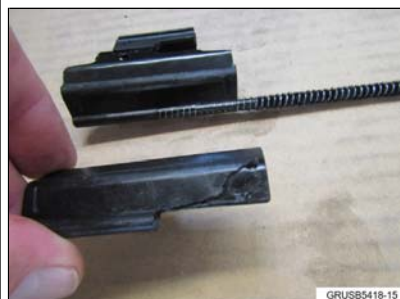
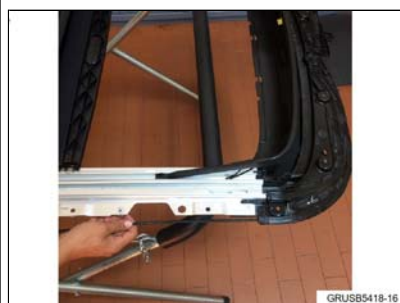
Note: If a drive cable has broken inside the track, it can be removed from the track using one of the replacement cables. To remove a broken cable, insert a spare cable into the opposite end of the track and push the broken cable out as seen to the left.

3. If broken sunroof drive components are found, replace both drive cable mechanisms following repair instructions **REP 54 13 200 “Replacing drive cable”**.
