Service Bulletin

15-039

10076 Version 4

Transmission End Cover Leaks (9-Speed A/T)

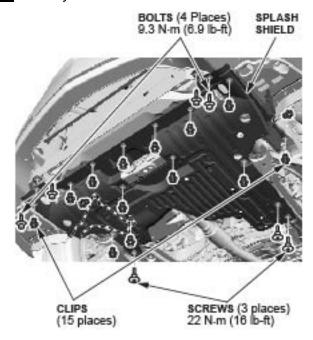
TLX Only: Remove the undercover.

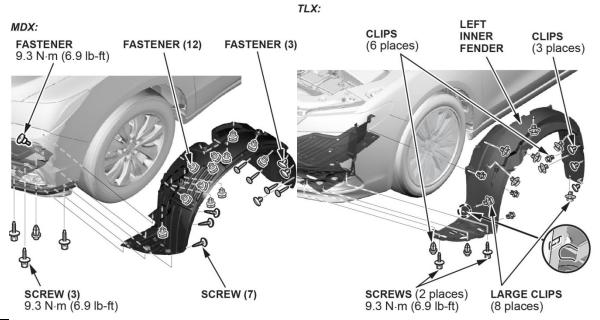
Loosen and remove the fender liner as needed to access the transmission end cover.

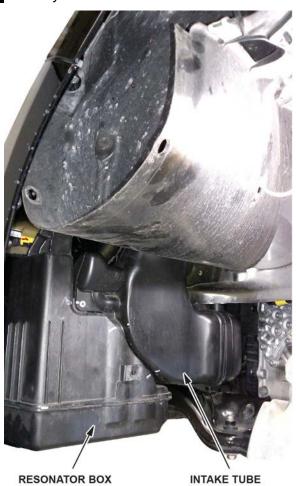
- Use a strap to hold the fender liner out of the way.
- TLX Only: Remove the resonator box and move the intake tube.

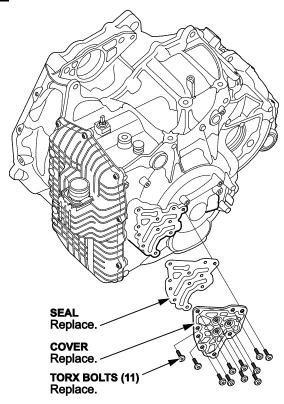
Remove the 11 T-30 Torx bolts from the end cover.

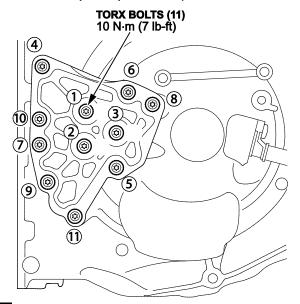
During assembly, the transmission end cover sealing gasket gets torn.

Replace the cover, the sealing gasket, and bolts with the new ones from the kit. Torque the bolts to **10.0 N·m (7 lb-ft)** in the sequence shown.

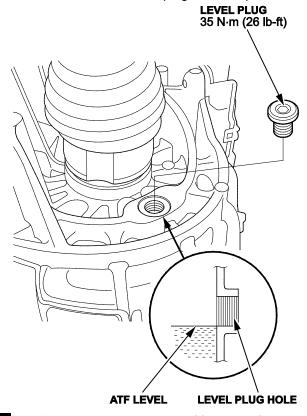
- If a small amount of ATF trickles out of the level plug hole and keeps doing so, the level is OK. Install a new level plug, and torque it to **35 N-m (26 lb-ft).**
- If no ATF comes out, loosely install a new level plug and lower the vehicle. Remove the fill plug, and add the appropriate amount of ATF Type 3.1 through the fill plug hole. Then, install a new fill plug, and check the ATF level again by removing the level plug. Be sure to monitor the ATF temperature while doing this. When you're done, install the level plug, then torque the level and fill plugs to 35 N·m (26 lb-ft).
