September 28, 2018

Version 4

## 2012–15 MDX: Judder from the Torque Converter Lock-Up Clutch After Software Update (Snapshot Upload Required)

Supersedes 16-063, dated March 09, 2018, to revise the information highlighted in **yellow**

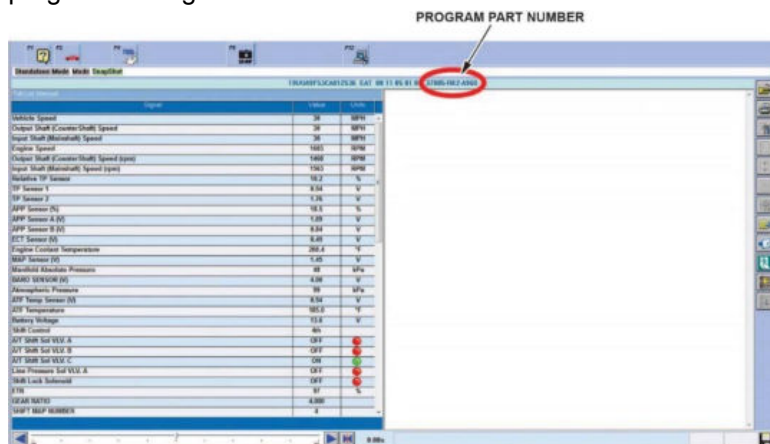
1. Connect the i-HDS and go to the A/T Data List. Check to see if the software has been updated by comparing the program P/N against the table below.

- If the program P/N is listed below (or later), the vehicle has been updated. Go to step 2.

- If the program P/N is not listed, the vehicle has not been updated. Go to Service Bulletin 16-062, 2012-15 MDX: *Judder from the Torque Converter Lock-Up Clutch (Snapshot Required)*.
2. Take an automatic transmission snapshot and forward it to Tech Line using the RO number. For more information about capturing and interpreting the data, refer to the job aid *Torque Converter Clutch Shudder and Vibration* and the Tech2Tech® video *Interpreting Torque Converter Judder Snapshot Data*.
    - If the snapshot indicates there is a judder, go to REPAIR PROCEDURE.
    - If the snapshot does not indicate a judder, this bulletin does not apply. Continue with normal troubleshooting.
